ASSESSMENT OF STRUCTURAL DAMAGES USING NON-DESTRUCTIVE AND SEISMIC INSTRUMENTATION METHODS. CASE STUDY OF AN EDUCATIONAL BUILDING IN BUCHAREST

Structural damages

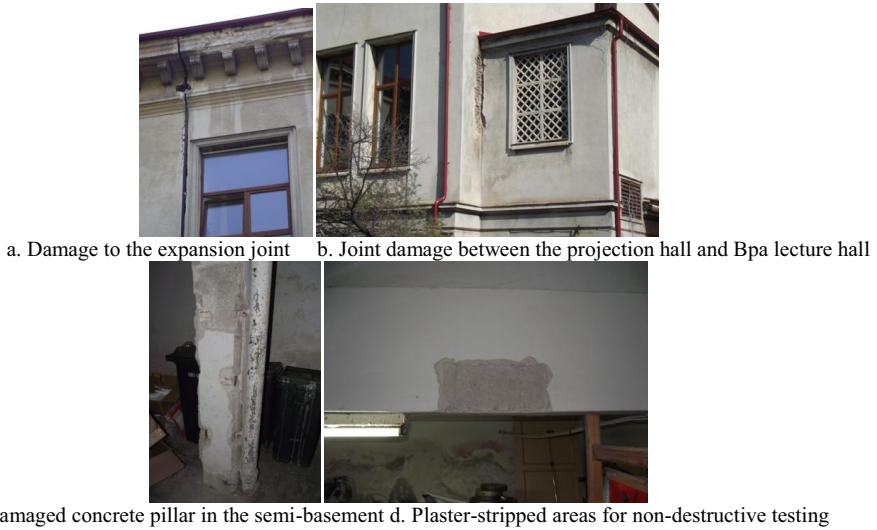
The two wings of the building show cracks and fissures caused by the earthquake on March 4, 1977 and reactivated by the 1986 and 1990 earthquakes. There have been no interventions in the building structure during its approximately 60 years of service.

Figure 4. Main structural damages of the Horticulture Faculty building

Figure 4a shows that the 2.00 cm expansion joint plays no role as a seismic point since the two wings collided with each other, probably due to their different rigidity (different structural systems) particularly since the two wings have large heights (approx. 16.00 m). It was found that the metal bars supporting the outer load-bearing walls and the roof of the Bpa lecture hall were not protected against corrosion.

The major structural damages of the building are shown in Figure 4.

To conclude, it is considered imperative to consolidate the building of the Horticulture Faculty. In addition to the building solutions presented in Expertise no. 1131/1993, building systems based on composite materials can be adopted in various forms which can be applied on one or on both sides of the wall. The solution is present among the consolidation measures included in P100-3:2008. In this case, the shear force capacity of the masonry wall plated with composite materials is given by the contribution of the composite material and the masonry.

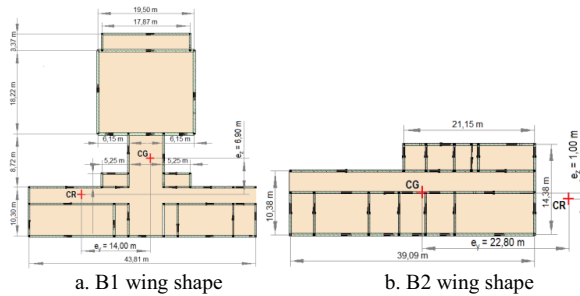
The plan shape of the wings is irregular, showing symmetrical discontinuities, ins and outs, resulting in additional pressure. The values presented in the figure above, and detailed in Appendix A, show that the Horticulture Faculty building plan does not comply with the regularly conditions imposed by both P100-1: 2006 Code and SR EN 1998.

Figure 6. Eccentricities according to the two orthogonal directions
