BUILDINGS BEHAVIOUR TO SEVERE SURFACE EARTHQUAKES (CHILE 2010, NEW ZEALAND 2011, TAIWAN 2016)

Claudiu Sorin DRAGOMIR^{1,2}, Daniela DOBRE^{2,3}, Emil-Sever GEORGESCU²

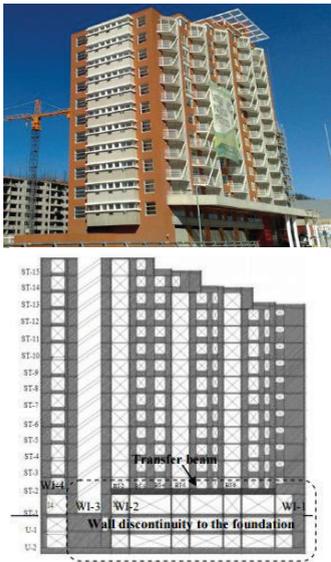
Figure 1. Some severe irregularities and discontinuity of walls at the base of the structural system (Kohrangi et al, 2012)

- building was in an eccentric position respect to the whole basement;
- some severe irregularities and discontinuity of walls at the base of the structural system;
- the transverse reinforcement was not done properly with sizes of building and the wall thickness was not increased proportionately to reflect a greater height regime;
- the lack of bulbs at the ends of the structural walls;
- the relatively high levels of wall axial load (the wall axial tensile forces were probably underestimated) etc.

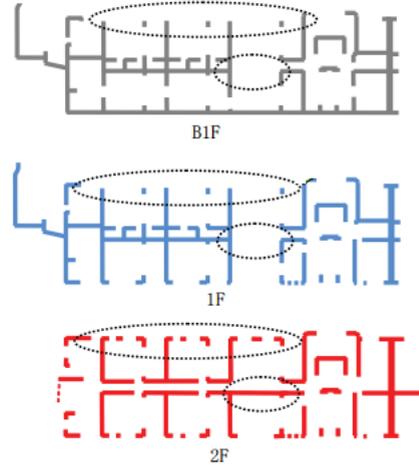
Also, the walls on the first floor and the basements (parking lot) are smaller than those on the second and above floors in both length and there is a difference in wall volume and layout among basement, first floor, and second floor, Figure 2, 3.

Figure 2. Difference in wall volume and layout among basement, first floor, and second floor (Saito et al, 2010)

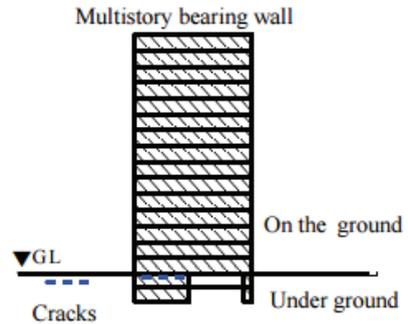
Figure 3. Schematic illustration of multi-story bearing wall with large opening at basement (<http://www.kenken.go.jp>)

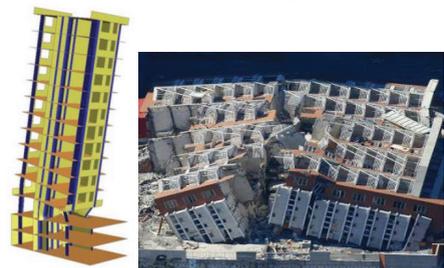
Figure 4. Damage modelling and view of collapsed building (<http://www.nehrp.gov/pdf>)

From this fact, the damages on the wall footing on the basements have resulted. The walls failed in the first story, causing the overturning of the entire building.

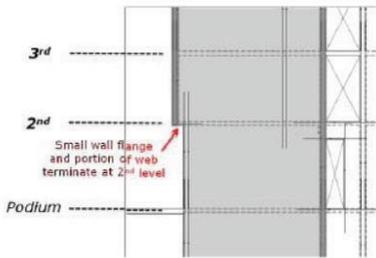
Figure 5. Details of vertical discontinuities of a shear wall (http://www.nehrp.gov/pdf/GCR%2014-917-25_RecommendationsforRCWallBuildings_std.pdf)

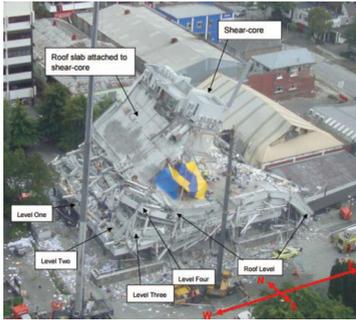
Figure 14. General Location of Main Structural Components after Collapse (<http://www.building.govt.nz>)

The building collapsed when the reinforced concrete walls of the core of the structure between level 1 and level 2 failed. Subsequently, the perimeter columns and/or joints between the columns and the beams and

the connections between the floor slabs and the shear-core failed, causing the floors to collapse.

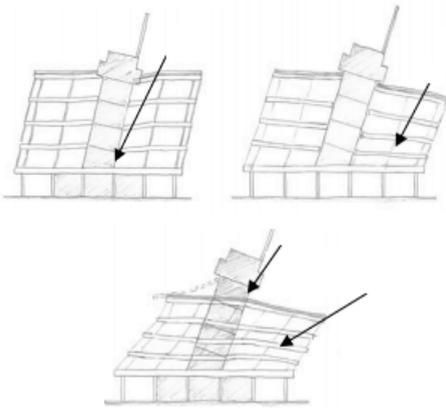
Figure 15. Time evolution of failure. Crushing of wall concrete, Failure of column/joints in compression, Failure of slab/wall connection, Failure of steel props (Beca Carter Hollings & Ferner Ltd (Beca) 26th September 2011)

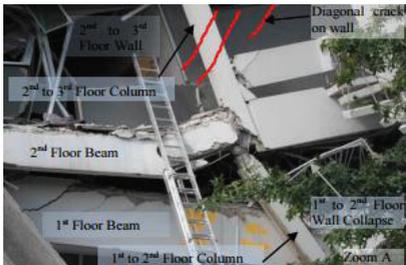
Figure 16 a. Various failure mechanisms observed on the Northern elevation of the collapsed PGC building (<http://www.nzsee.org.nz>)

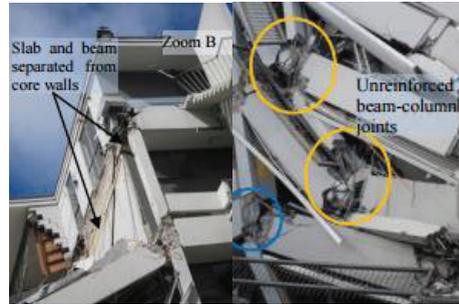
Figure 16 b. Various failure mechanisms observed on the Northern elevation of the collapsed PGC building (<http://www.nzsee.org.nz>)

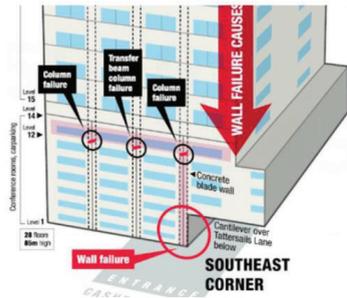
extend out to the east at levels 12 to 14 above Tattersalls Lane to support the car park floors. The wall with a plate cantilever supported between 600 and 800 tons from weight higher levels. It is estimated that during the earthquake, this wall has undergone a request side 1800 to 2400tf. Two of these cantilevered transfer beams sit on top of the key supporting shear wall (wall D5-6), Figure 17. The damaged foundations lead to the visible leaning of the building to one side, Figure 18.

Figure 18. Failures of columns, transfer beam column, concrete wall (<http://sciblogs.co.nz>)

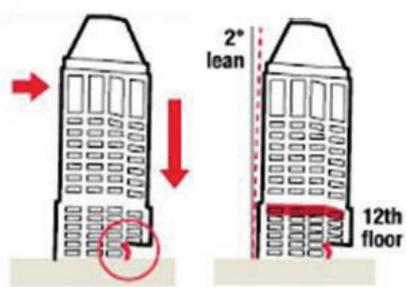
The wall failure and the south-east corner of the building dropped by approximately 800 mm and developed an accompanying horizontal lean of approximately 1300 mm at the top of the building, Figure 19.

Figure 19. Wall failure and the south-east corner of the building (<http://sciblogs.co.nz>)

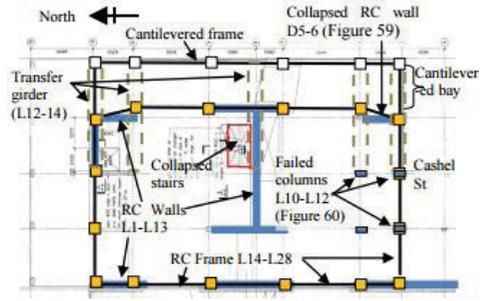
Figure 20. (<http://www.nzsee.org.nz>)

The building suffered structural damage, caused by the collapse of a key supporting shear wall "D5-6" located in the south-east corner of the building, Figures 20...23. The shear wall was responsible for roughly one-eighth of the Hotel Grand Chancellor's mass.

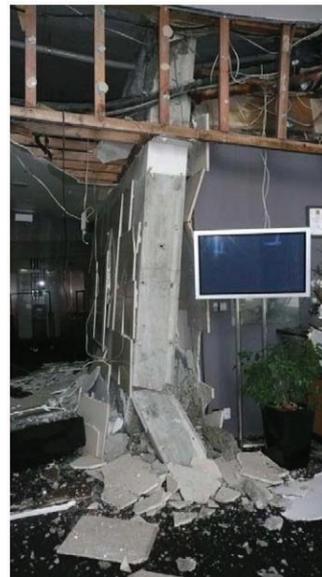
Figure 22. Shear wall D5-6 base failure. A lack of steel reinforcing in the concrete was the biggest factor in the shear wall's failure which failed in a brittle manner. This shear wall had supported vertically approximately one eighth of building's mass and was also expected to carry a portion of lateral earthquake loads

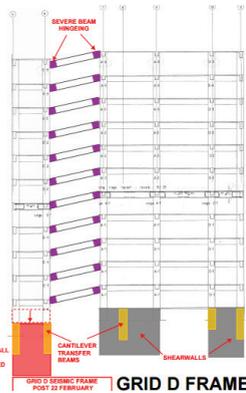
Figure 24. Details of cantilever transfer beams, with severe beam hinging (<http://www.building.govt.nz>)

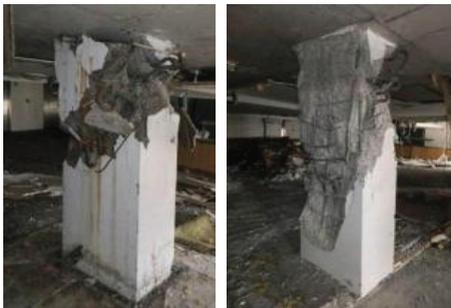
Figure 25. Grand Chancellor Hotel: The shear-axial failure of the RC columns below the transfer girders at Level 10 and 11.

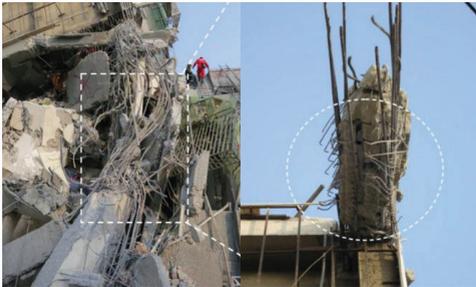
- the design of the construction did not match calculations made in its structural and steel blueprints;
- the difference in stiffness between the apartments above and the soft storey below causing failure at the junction between the two (at second floor level);
- at the bottom of the building, a possible soft storey which has caused the overturning of the entire structure;
- the possibility of structural problems related to poor-quality reinforced steel and cement;
- only half the designated amount of reinforced steel beams were used in the construction of the complex, which explains its weak structural integrity;

- there is a high likelihood that the basement acted as a soft storey and caused the building to collapse;
- some residents in the building broke and cleared many in fills and columns of a storey so that more rooms could be arranged for rent.

Figure 28. Some 90-degree bend hooks (<http://www.businessinsider.com>)
