## 3D FINITE ELEMENT ANALYSIS MODEL TO ACCESS THE SETTLEMENT OF SOFT SOIL TREATED WITH NANO-MgO

Ahmed AL-RUBAYE, Anton CHIRICA, Ioan BOTI

Technical University of Civil Engineering Bucharest, 124 Lacul Tei Blvd,  
District 2, Bucharest, Romania

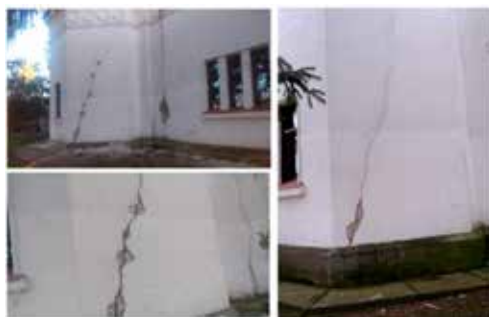
The physical condition of the church is precarious: fractures, cracks, and fissures have been identified in the masonry, caused by uneven settlements. These settlements which are exceeding 30-40cm are mainly caused by the increase of groundwater table level in time. The roof sheet is corroded, and the water collection and drainage system are damaged. The vertical systematization of the land is improperly made, unfinished and damaged.

The area is known for the presence of loessoid deposits which are water sensitive. Their thickness may easily exceed 10 m, in Perișoru area. The main reason for problems of the structural failure element (Figure 2) is the rising in the groundwater level, in addition, most of the existing buildings were built during this period when seismic action was not considered in the design, so they were built from the beginning by traditional methods and designed only for rapacious actions (Hemeda, 2019).

Figure 2. Deformations and cracks on the Brick Walls of Church Adormirea Maicii Domnului, Perișoru

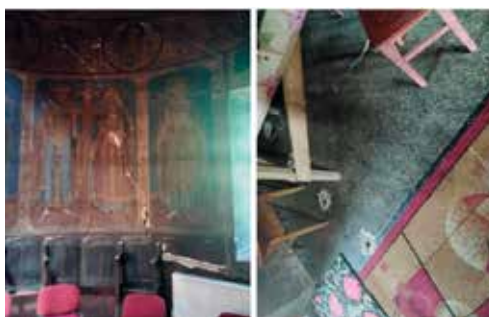
Figure 3. Deformation and Cracks in the Different Structure inside the Church Adormirea Maicii Domnului, Perișoru

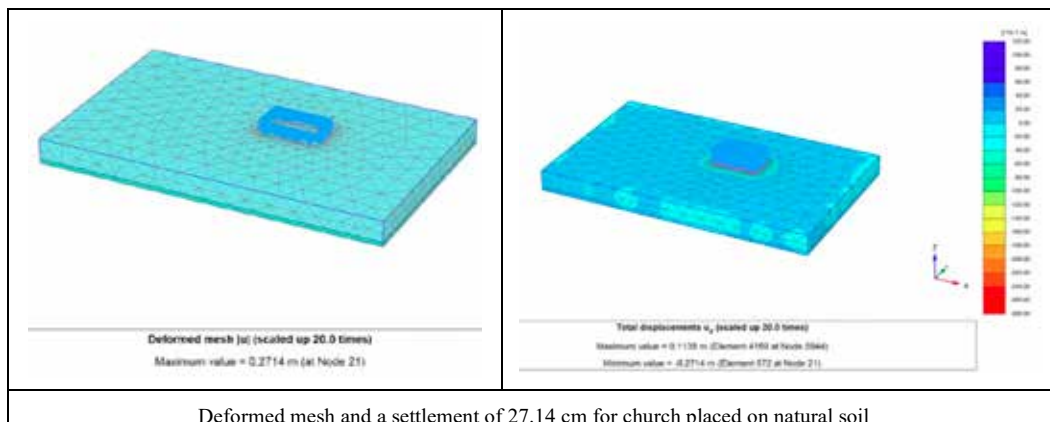
Deformed mesh and a settlement of 27.14 cm for church placed on natural soil

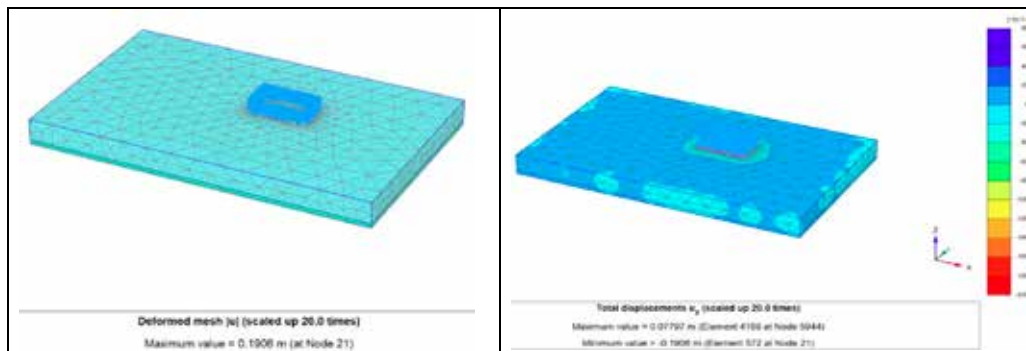
a. Deformed mesh and a settlement of 19.06 cm for church placed on soil treated with 0.5% nano-MgO

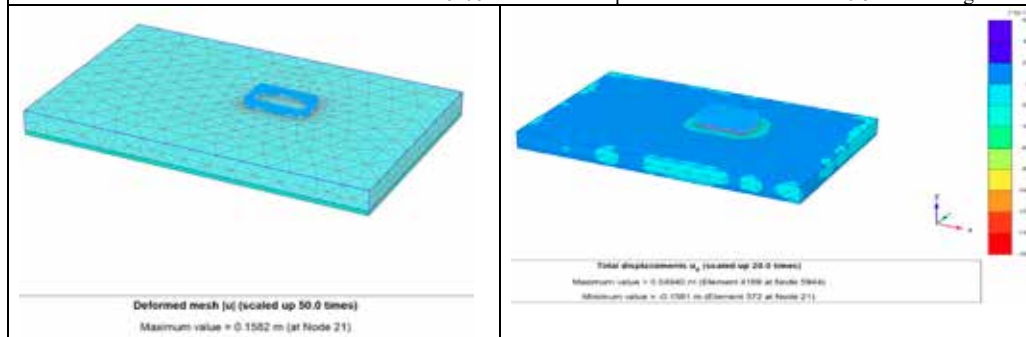
b. Deformed mesh and a settlement of 15.82 cm for church placed on soil treated with 0.75% nano-MgO

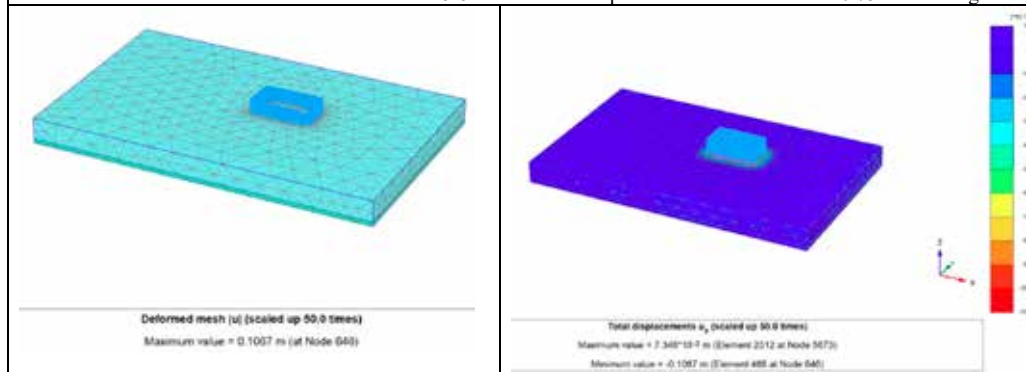
c. Deformed mesh and a settlement of 10.67 cm for church placed on soil treated with 1% nano-MgO

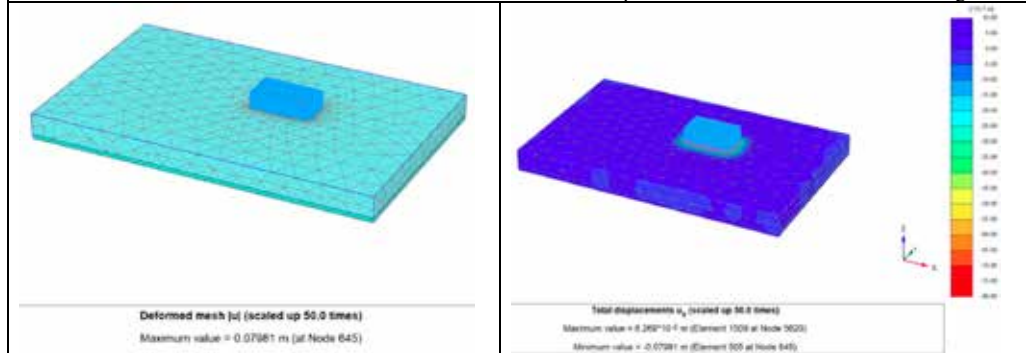
d. Deformed mesh and a settlement of 7.98 cm for church placed on soil treated with 2% nano-MgO
