## THE NEGATIVE IMPACT OF SINKHOLES IN AGRICULTURE LAND: THE CASE OF KONYA

### **Abstract**

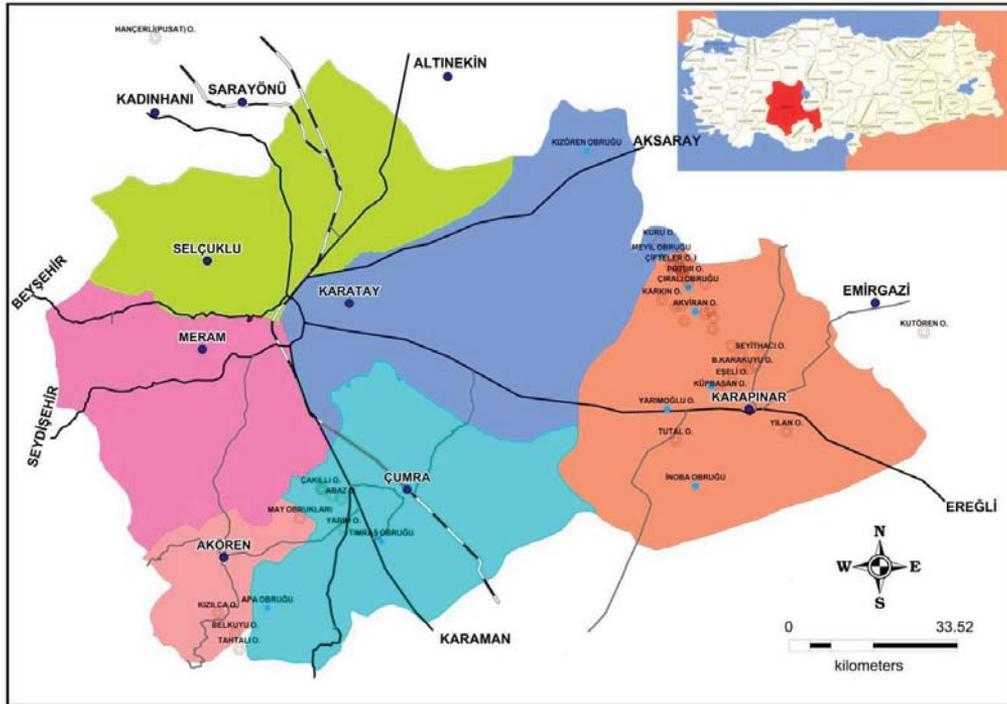
Figure 1. Distribution of the sinkholes in Konya

sinkholes in Konya into two groups, as old and newly formed (Figure 1).

There are many sinkholes in Konya province which has recently emerged and are going on emerging today. Significant amount of recently formed sinkholes have emerged in Karapınar district (Figure 1). While sinkholes today sometimes slightly show indications, sometimes they collapse without any indications.

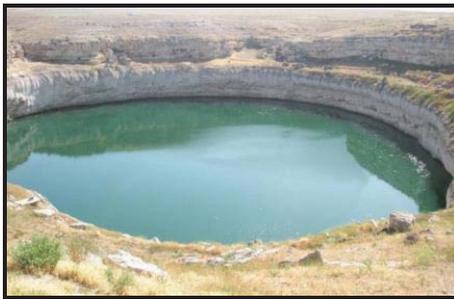
Figure 2. Kızören Sinkhole from south

**Kızören Sinkhole:** It exists in the east of Konya centrum, on the highway between Konya and Aksaray, in the 4 kilometers north of Kızören Town (Figure 2). The sinkhole had emerged in Upper Paleozoic old crystalized limestones and Upper Miocene-Pliocene old lacustrine formations. Upper elevation of the

sinkhole seen in circular shape is 1004 meters in average; its water surface elevation is 973 meters. Long axis of the sinkhole in east-west direction was determined as 341 meters, and its short axis in north-south direction was determined as 182 meters. Although Selçukbiricik (1992:103) remarked the lake depth of the sinkhole as 145 meters, today, this depth has slightly decreased due to the ebbing of underground water. Kızören Sinkhole and the area of 127 hectares around it were involved in contract list as Ramsar Convention in 2005.

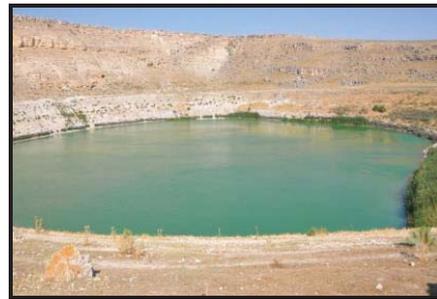
Figure 3. Meyil Sinkhole from North

**Meyil Sinkhole:** It's located in the Meyil Plateau in the 40 kilometers northwest of Karapınar (Figure 3). The sinkhole had emerged Upper Miocene-Bavention old different layers. The elliptic sinkhole's upper elevation is 1044 meters; its water surface elevation is 980 meters. Long axis of the sinkhole in east-west direction is 660 meters, and its short axis in north-south direction is 590 meters. The measurement in September, 2014 shows that

various fish live in the sinkhole whose lake depth is 40 meters.

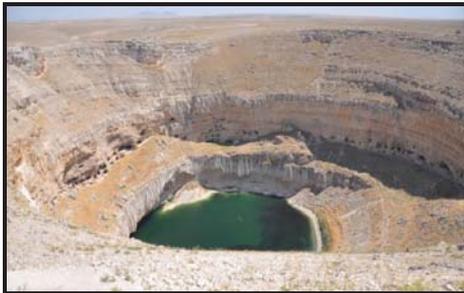
Figure 4. Çıralı Sinkhole Lake from north

**Çıralı Sinkhole:** It's located in the Çıralı Plateau in the northwest of Karapınar (Figure 4). The sinkhole had emerged in Upper Miocene-Pliocene old limestone, clayey limestone, marl, travertine limestones. Circular shaped sinkhole's upper surface axis is 354 meters, short one is 303 meters, its lake surface's long axis is 135 meters and short one is 120 meters. Its upper elevation is 1070 meters, its lake surface elevation is 966 meters

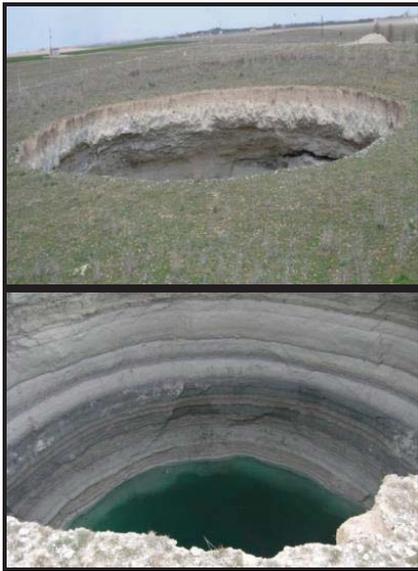
Figure 6. İnoba Sinkhole

**İnoba Sinkhole:** It's located in the southwest of Karapınar district center and 40 meters west of İnoba plateau habitation (Figure 6). The sinkhole emerged in 2008 in limestone, clay and marly formations. Its upper elevation is 1010 meters. While the sinkhole was in 25 meters caliber and 33 meters depth when it first emerged, today (October, 2013), it has a caliber of 29 meters and depth of 42 meters. The fact that the sinkhole is close to plateau habitation presents a great danger. Families around here stated that they had immigrated to Karapınar district center. The sinkhole formation is regarded as a significant danger for people who make a living from sheep-goat farming.

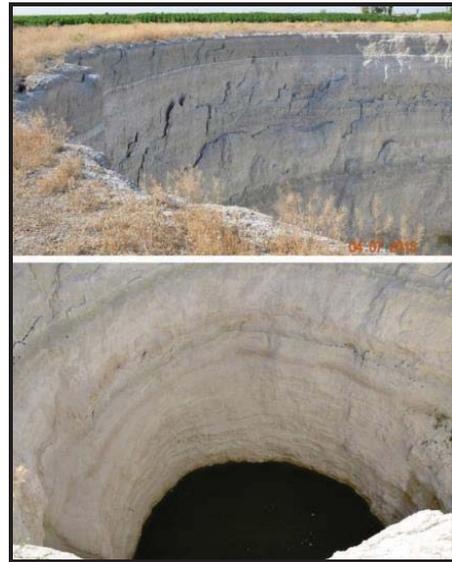
Figure 7. Yarımöğlü Sinkhole

**Yarımöğlü Sinkhole:** It's located in the Akkuyu Plateau in the west of Karapınar

district center. Sinkhole is occurred in the agriculture lands. When sinkhole was occurred corn was field land. The sinkhole emerged in 2009 in soil, clay and marly alluvion formations. Its upper elevation is 1010 meters. While the sinkhole had a caliber of 25 meters when it first emerged, the caliber has raised up to 28 meters in present day. Water exists at the part after almost 49 meters of sinkhole (Figure 7). Yarımöğlü Sinkhole attracts tourists as it is highly close to Konya-Adana highway. Edge of the sinkhole has been covered with simple barb wires. There's a serious danger for people visiting the sinkhole. Currently 350 m<sup>2</sup> there agriculture land were destroyed by sinkhole.

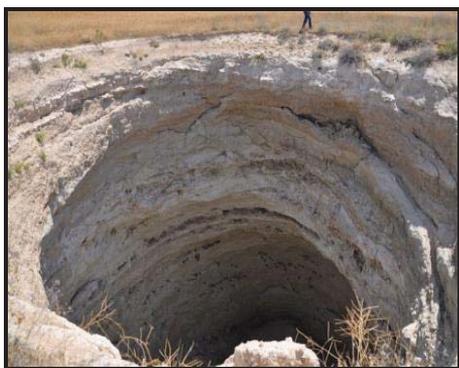
Figure 8. Nebili Sinkhole

**Nebili Sinkhole:** It's located in the north of Büyükkarakuyu Plateau. Its upper elevation is 1092 meters; its depth is 70 meters. The

sinkhole which had been wet since its emerging has become a dry sinkhole as underground water level went deeper 21. Sketchy ellipse shaped sinkhole's long axis is 18 meters, short axis is 16 meters (Figure 8). This makes it possible for pigeons to house.

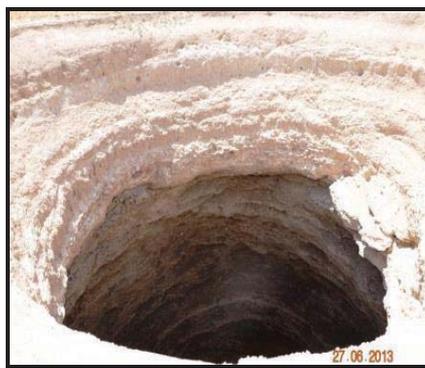
Figure 9. Akviran Sinkhole

**Akviran Sinkhole:** It's located in the northwest of Karapınar and north of Akviran Plateau. The sinkhole emerged in May, 1977 in Upper Miocene-Pliocene formations (Figure 9). Its upper elevation is 1046 meters, its depth is 80 meters and its calibre is 24 meters. There's 26 meters of range of ridge between the sinkhole's

upper surface and water level. It's observed that the shielless sinkhole presents a danger for

living beings. Currently 190 m<sup>2</sup> there agriculture land were destroyed by sinkhole.

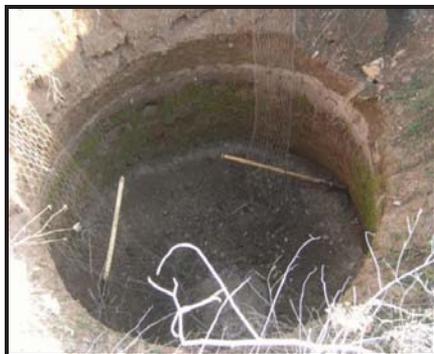
**İçeriçumra Çakillar Sinkholes:** 3 sinkholes emerged in different dates in İçeriçumra Çakillar Location. First of them emerged in 2005, the second one emerged in 2008, and the third one emerged in 2009. Each one of these sinkholes was plugged by landowners. First of them emerged in November, 2005 in İçeriçumra Çakillar Location. In our measurement in 2008, the caliber of circular sinkhole was determined as 5 meters, its depth was determined as 9 meters. During that period,

Figure 10. İçeriçumra Çakillar Sinkhole-I plugged in present day (Photo taken in 2008)

limestone, clay and marley layers on the slopes of the sinkhole could be prominently seen (Figure 10). Moreover, although the sinkhole hadn't been named yet, we stated that it would be proper to name it Çakıllı Sinkhole as the location where it had emerged was Çakillar (Bozyiğit-Tapur, 2009:149). However, when we went there to make a more detailed research, it was observed that the sinkhole had totally been plugged.

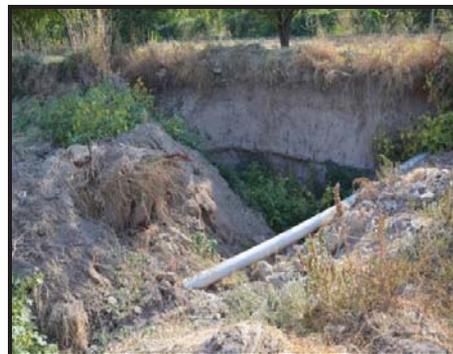
Figure 11. İçeriçumra Abaz Sinkhole plugged following its emergence

***İçeriçumra Abaz Sinkhole:*** It's located in the borehole fields in the west of İçeriçumra Town (Abaz Road). The sinkhole emerged in Quaternary old alluvion layers. Its upper elevation is 1027 meters; its depth is 8 meters. The calibre of sketchy circular sinkhole was measured as 10 meters. The sinkhole emerging in July, 2012 has been plugged with excavation materials (Figure 11).

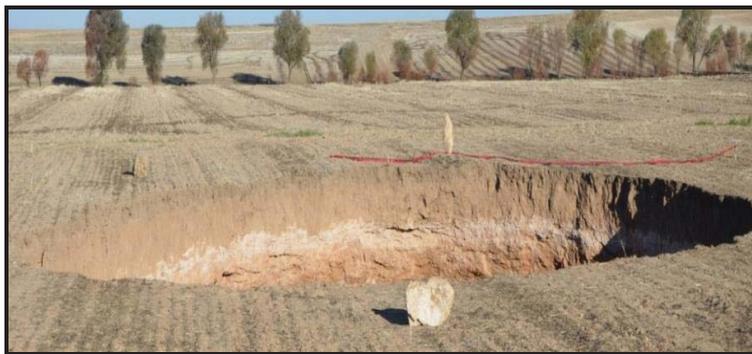
Figure 12. Kadınhanı Hançerli Sinkhole

***Kadınhanı Hançerli Sinkhole:*** It emerged in Pusat Village in Kadınhanı district.

The sinkhole emerged in Upper Miocene-Pliocene old lacustrine cover formation (Figure 12). Its elevation is 1004 meters; its depth is 7 meters. Its long axis in the direction of east-west is 18 meters; its short axis in the direction of north-south is 13 meters. The escarpments are more in the north and east slopes of the sinkhole. There are block collapses and deep cracks in the west slope and piles of debris in the south slope. As the sinkhole is highly new, its process of formation is going on.

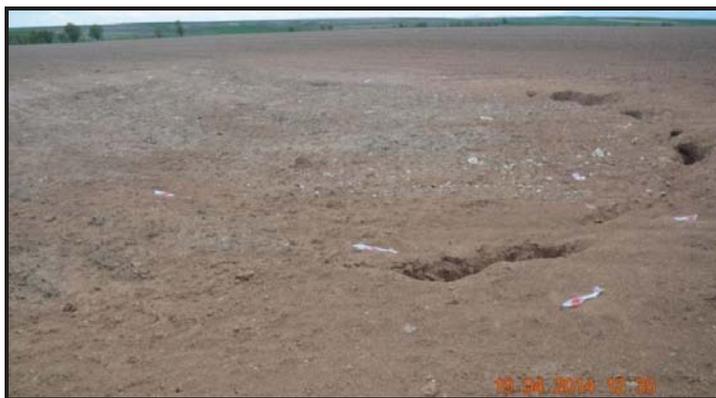
Later on, found out that the sinkhole had been plugged with excavation by the farm owner 4 months after its emergence, it was seen that the sinkhole had been plugged when we performed a research on the sinkhole field in April, 2014. It can be seen that the sinkhole had collapsed about 1 meter and cracks occurred on the edges of the sinkhole although we researched 2

months after it was plugged (Figure 13). Plugging it increases the possibility of a bigger collapse as the sinkhole hasn't totally collapsed. Although the owner of the farm where sinkhole emerged was informed about this danger, he didn't give up his insistence. He carries on his agricultural activities by plugging the sinkhole emerging on his farm.

Figure 13. The closed display of Kadınhanı Hançerli Sinkhole after 6 months
