## ENVIRONMENTAL ASSESSMENT ON AN INDUSTRIAL SITE LOCATED IN VRANCEA COUNTY ROMANIA

*The case study presented in this paper refers to the approach taken to investigate and to quantify the potential historical pollution for a former industrial land, after the end of activities.*

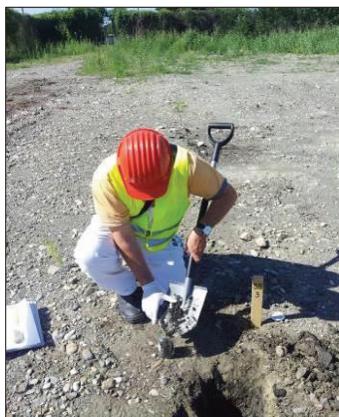
Figure 3. Sampling of SS3

Examples from the sample works operations are shown in Figures 3, 4 and 5.
