NOWADAYS SITUATION OF DRAINAGE SYSTEMS IN THE MOLDOVA RIVER WATERSHED

Minodora AILENEI (RADU), Oprea RADU, Daniel BUCUR

Abstract

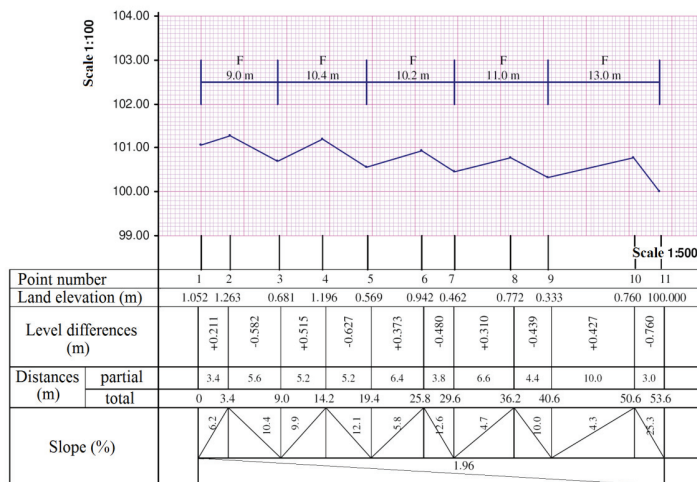
The transverse profile analysis (Figure 2) reveals land shaping in the bedding with ridges and furrows with values of the furrow-ridge level differences ranging between 0.211 m and 0.760 m and transverse slopes of 4.3% to 25.3%, due to the individual soil works on the various plots of land.

Figure 2. Land shaping by individual soil works

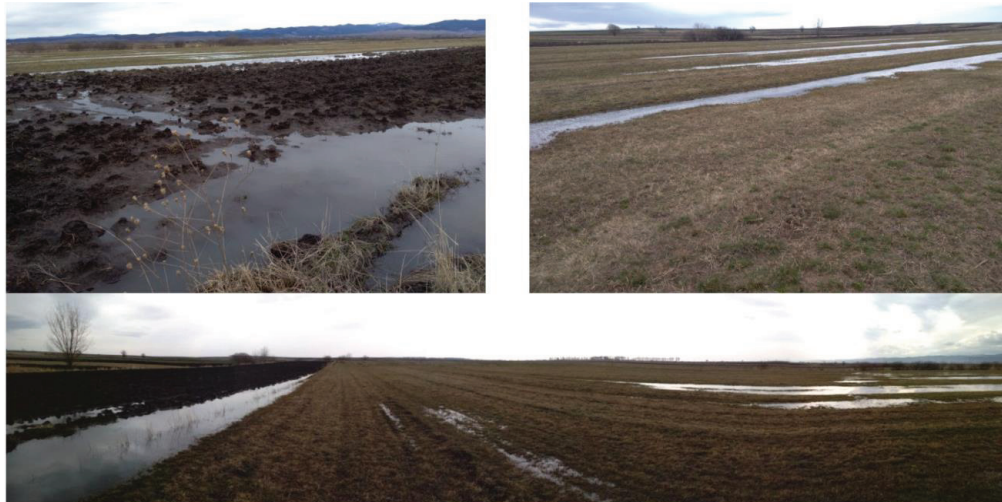
Land shaping due to individual soil works on various plots of land, which does not match the routing of the plastic drain lines and of the drainage network, allows the water to stagnate

in the furrows and extend the excessive humidity period. Thus, this land has gradually turned from arable land into grass land (Figure 3).

Figure 3. Land shaping and stagnating water in the furrows

Individual soil works on plots of land have led to land shaping in the bedding with ridges and furrows, which does not match the routing of the plastic drain lines and of the drainage network, allow the water to stagnate in the furrows and extend the excessive humidity period, and implicitly unevenly discharge the excessive water in the land with draining systems.

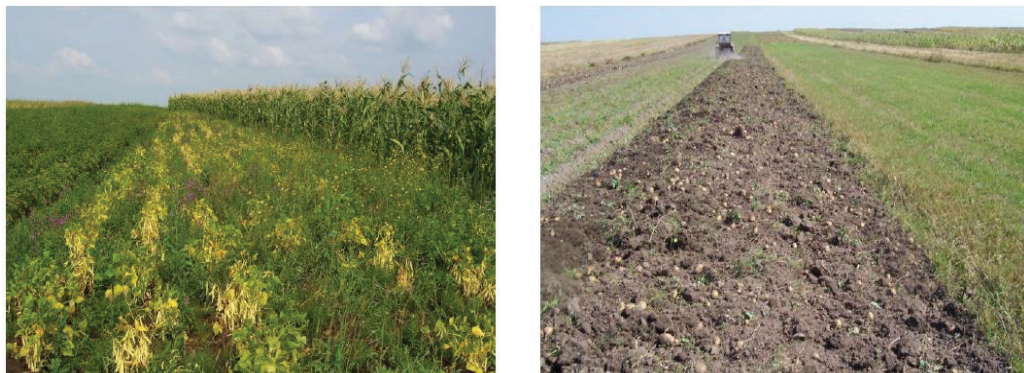
Whereas before 2014-2015, in the Rotopanesti-Radaseni-Fantana Mare surface and subsurface drainage system, the land was used as individual plots (Figure 4), now, due to the lack of workforce caused by an ageing population and due to the occurrence of private entrepreneurs, the land has been taken over and used uniformly on large compact areas or on drainage sectors.

Figure 4. Use of agricultural land on individual plots

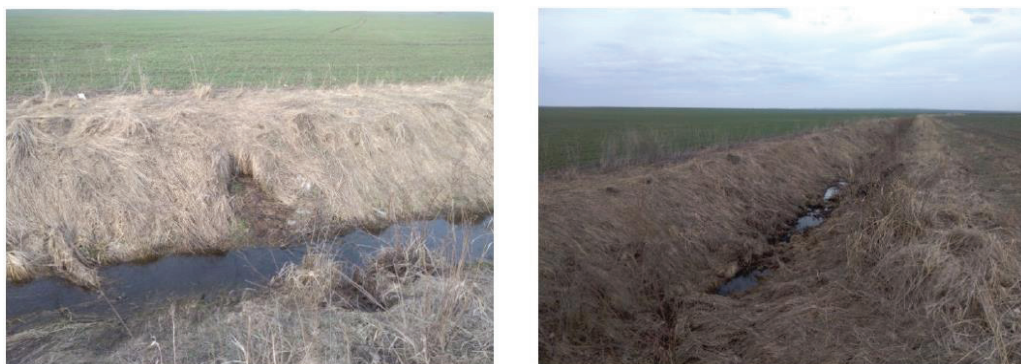
On the left side of the Dumbraва main collecting drain, where the land has been used compactly for several years, the furrows and ridges were generally abolished, which allows for the excessive water from heavy rainfall of 1-5 consecutive days and from snow melting to be easily discharged (Figure 5).

Figure 5. Use of land on drainage sectors

The analysis of the section of the Dumbrava main collecting drain (Figure 5), which serviced mainly arable pieces of land for about 40 years, reveals its natural slitting. Drain slitting is due to the non-performance on time of maintenance works, to the fact that the grass was not cut and the wooden vegetation was not removed, which increases roughness, reduces the water flowing rate and supports the deposition of alluvial sediments in the drain section.

Land use on drainage sectors has allowed the abolishment of furrows, ridges and small depressions and hence the discharge of excessive water.

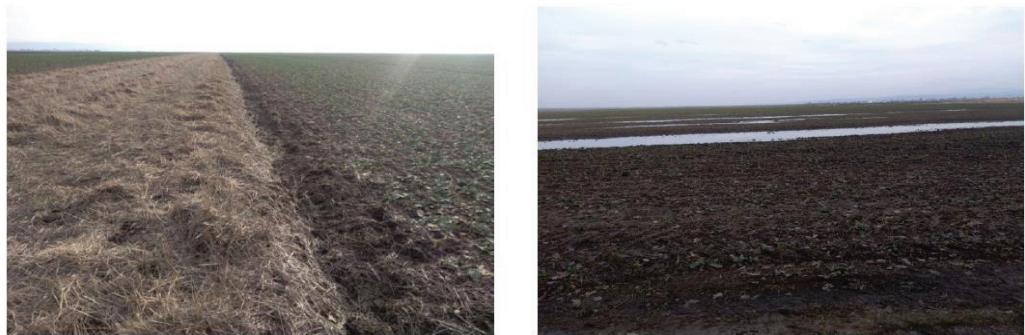
On the right side of the Dumbrava main collecting drain, where the land is used both on individual plots and on larger areas, we found that water stagnates and excessive humidity lingers in furrows and small depressions. Water stagnation on this side of the drain is due to the fact that the land has been used on larger areas for a little while, the areas are smaller and alternate with individual plots, which hinder the performance of soil works in optimal conditions, as the furrows and small depressions have not been completely removed yet (Figure 6).

Figure 6. Land use on larger areas and individual plots

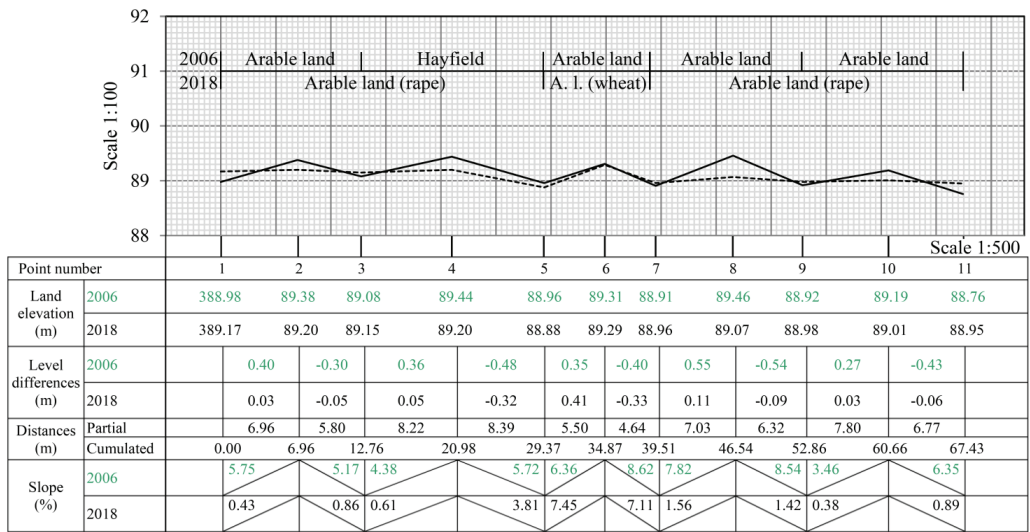
In the cross profile (Figure 7) it is found that in 2006 the surfaces resulted after modeling processes have slopes between 3.5% and 8.6%. The level differences between the highest and lowest altitudes of sloped surfaces were range between 0.27 m and 0.55 m. In 2018, the amplitude values of level differences ranged between 0.33 m and 0.41 m. The slope of the surfaces varied between 7.1% and 7.5% for the small individually parcel. In large plots, values

of level differences were only by 0.03 m and 0.32 m and transverse slopes ranging from 0.4% to 3.8%.

Figure 7. Land shaping in 2006 and 2018

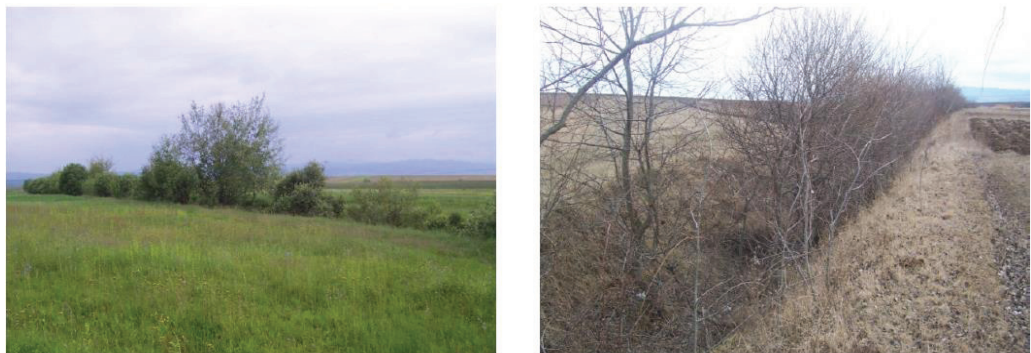
At the time of our field observations, the Dumbrava drain section was cleared of the wooden vegetation, but the surface and subsurface drainage systems, which include a network of drains of various sizes, were generally invaded by well-developed wooden vegetation (Figure 8). The discharge holes in the surface plastic drains were less clogged than the collecting drains located deep into the

Figure 8. Shrub vegetation in the canals

As maintenance works have not been performed from time to time, this has gradually led to the erosion of slopes and to the slitting of the canal network and of the discharge holes in the drains, which caused excessive humidity to reoccur.

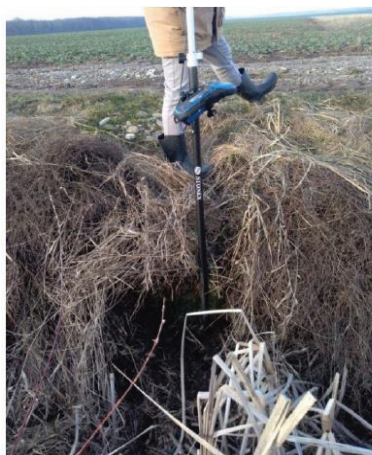
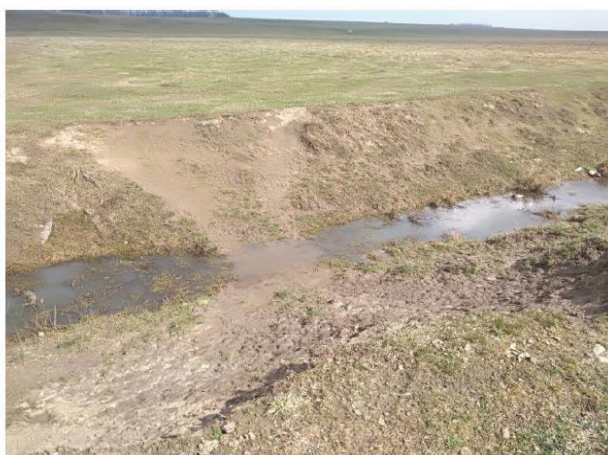
ground. The discharge holes in the plastic drains of inferior rank and in the drains located on grass land were more clogged than the others (Figure 9).

Figure 9. Discharge holes in clogged plastic drains

The discharge holes in the plastic drains of inferior rank and in the drains located on grass land were more clogged than the others.

The discharge holes in the collecting drains, which are deeper into the ground than plastic drains, were clogged both in the grass land and in the arable land.
