THE EFFECT OF DEFORESTATION IN THE SIHASTRIA WATERSHED, SUCEAVA COUNTY, ON THE TECHNICAL EFFICIENCY OF THE SMALL HYDROELECTRIC POWER PLANT

Constantin Dragos MOTCO, Simona Gabriela CIOCAN, Daniel BUCUR

„Ion Ionescu de la Brad” University of Agricultural Sciences and Veterinary Medicine of Iasi

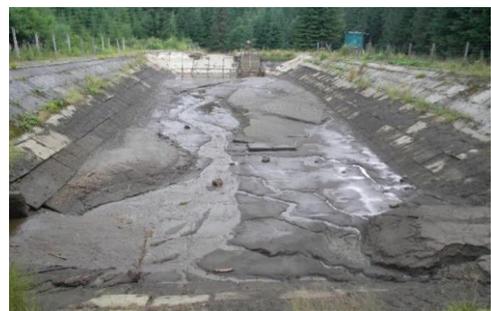
Figure 4. Clogged forebay tank

- The forebay tank (Figure 4) must be unclogged at least once a year, the cost of this unclogging process is between 4000 - 6000 euros, during which the power plant is

decommissioned for up to 7 days, which leads to an average loss of 19.93 MWh;

The main cause of clogging is uncontrolled deforestation that favors increased soil erosion.

The forebay tank (Figure 3) must be unclogged at least once a year; the cost of this unclogging process is about 5,000 euros. For 7 days the power plant is switched off, with an energy loss of about 20 MWh.

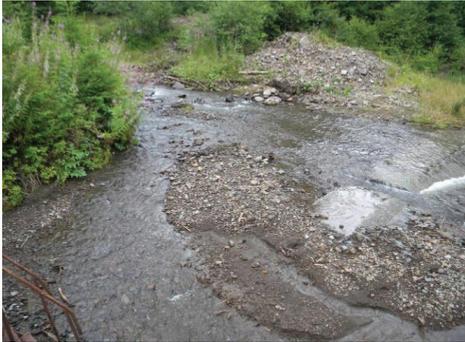
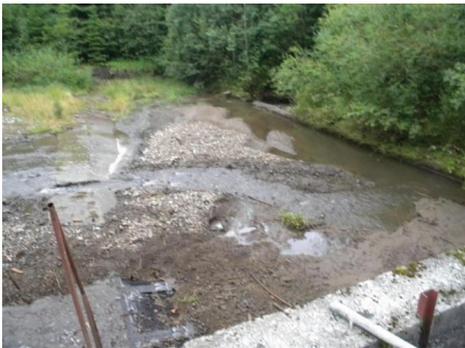
- Water capture zone (Figures 5 and 6) located on the stream bed is clogged about 3 times a year, the cost of its unclogging ranging from 250 - 500 euros depending on the mass of clogging, the unclogging process takes between 8-12 hours and leads to a loss of 3.3 MWh per year.

Figure 5. Clogged intake

Figure 6. Clogged intake

- The absence of anti-erosion measures on the slopes increases the erosion process, large amounts of plant residue reaching the stream bed.
- Because of the large amount of solid suspensions in the water used to produce electricity, as well as repeated unclogging made in the compensating reservoir, respectively capture zone, the degree of wear of the hydrotechnical construction and technical equipment (lines, turbines) has increased significantly.
