DEGRADATION OF VEGETAL COVER THROUGH INAPPROPRIATE GRAZING ON LANDS ARRANGED WITH DRAINAGE WORKS

Key words: clogging channel, drainage works, inadequate grazing, vegetal cover.

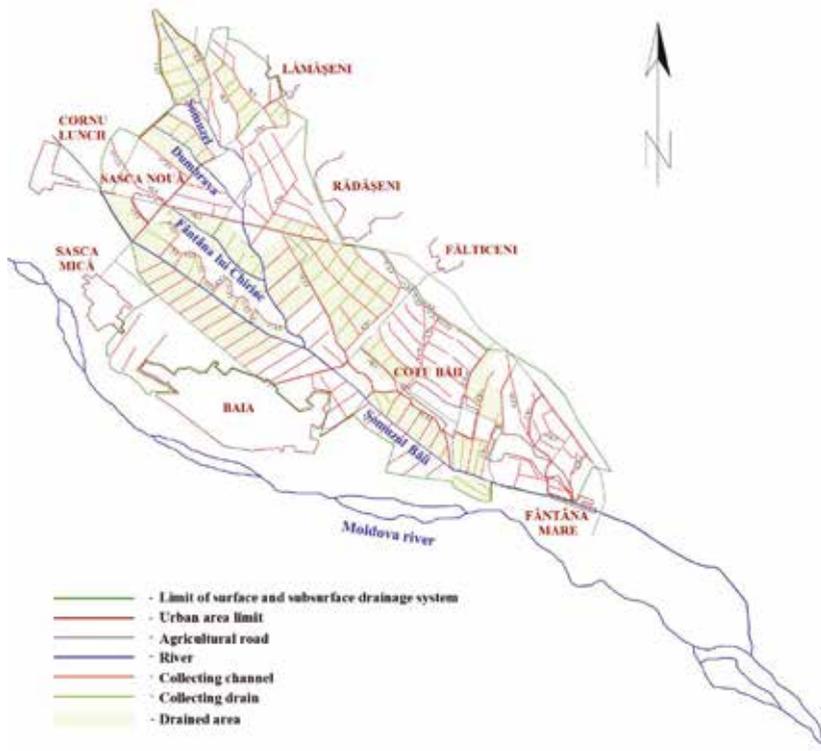
Figure 1. Surface and subsurface drainage system Rotopanesti-Radaseni-Fantana Mare

In order to increase the productive capacity of the lands, the surface and subsurface drainage system Rotopanesti-Radaseni-Fantana Mare was laid out, between 1978 and 1980, with an area of 5527 ha of which 1806 ha with underground drainage works (Figure 1).

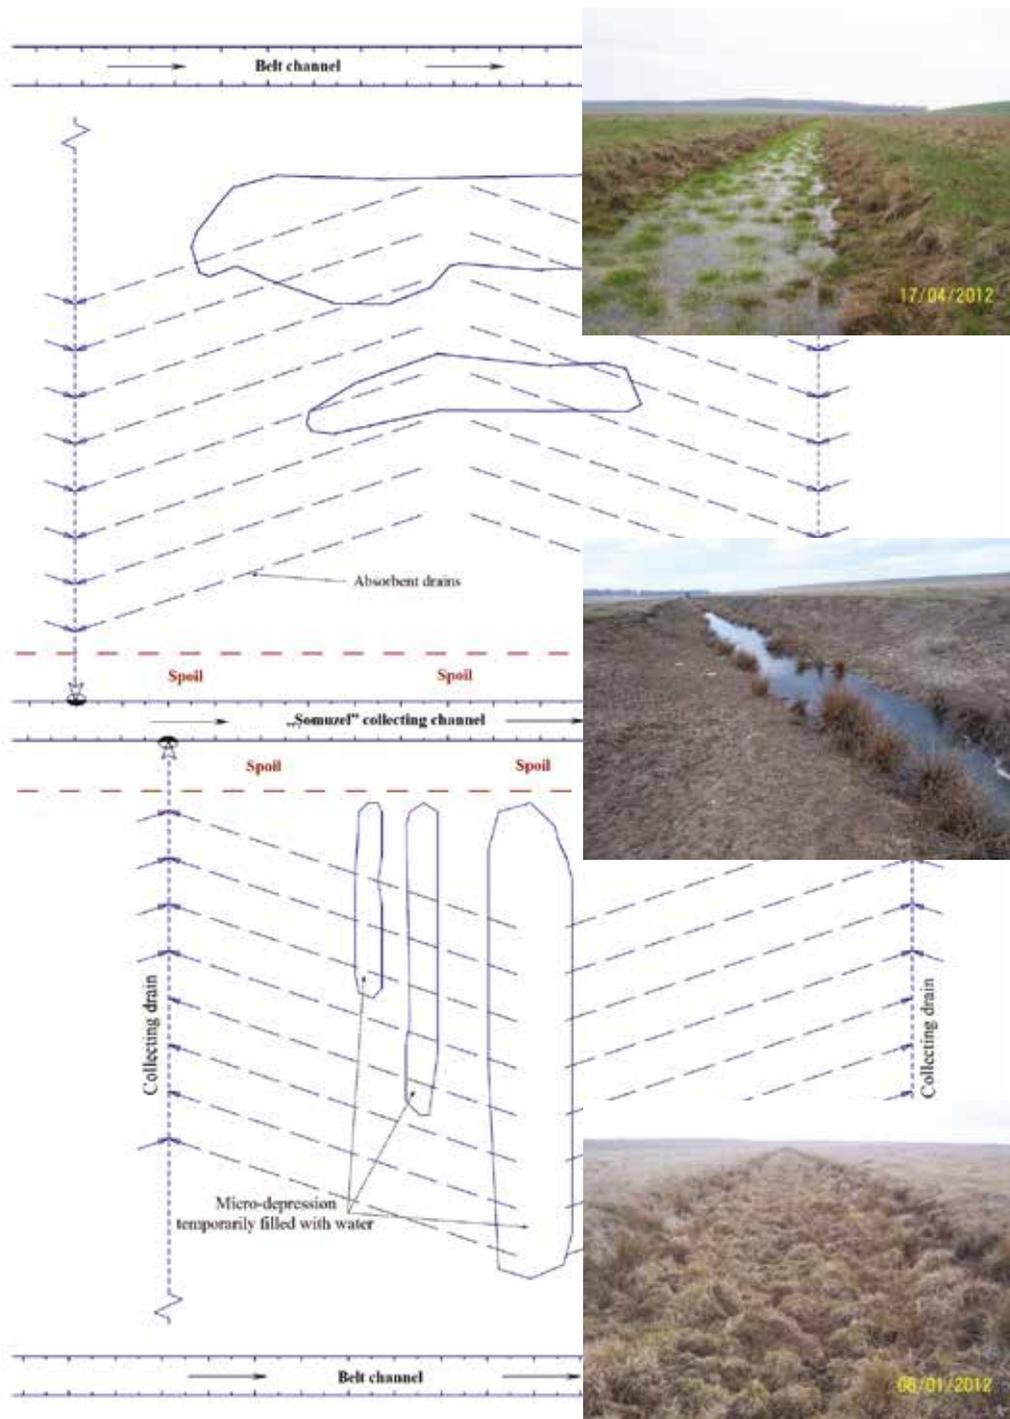
Figure 3. Draining layout scheme and current channel state

On the passing of the drained surface from arable use to pasture use, no layout was made for the animals crossing the Somuzel collector channel and the two belt channels, protecting the drained surface by intercepting leaks in the higher boundary areas.

Successive crossings and grazing on the channel section with moist soil accelerated shore erosion and clogging the drainage network (Figure 3).

Repeating this cycle year after year has led to the degradation of large grazing fields. For the restoration of the vegetational cover, it is necessary to start grazing later, to interrupt the grazing by at least 3-4 weeks before the first frost and to perform the rehabilitation works of the draining network.

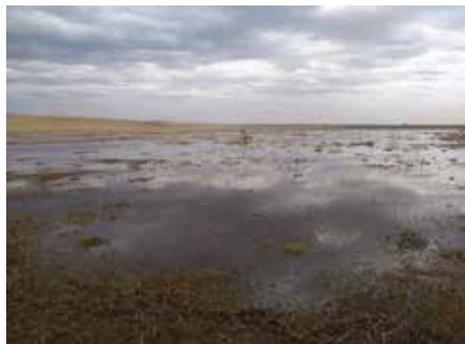
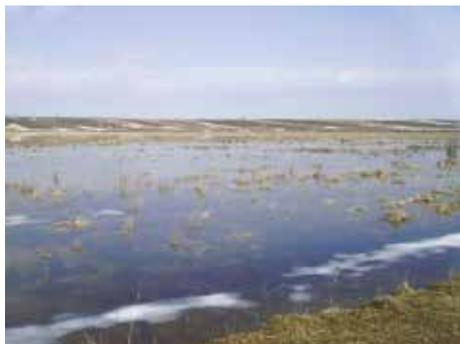
Figure 4. Water overflow on the drained surface

The clogging of belt channels of approximately 75% does no longer ensure the interception and transport of water coming from the higher perimeter areas. In the spring, on the melting of

snow and over periods of abundant precipitations fallen within 1-5 consecutive days, the accumulated waters overflow, flooding the drained surfaces (Figure 4).

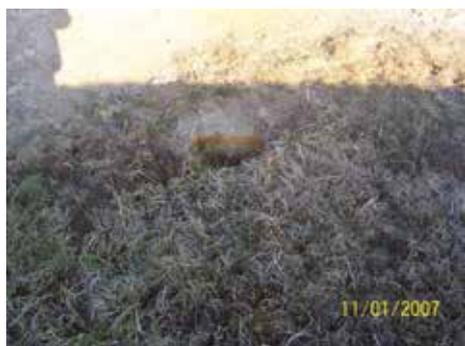
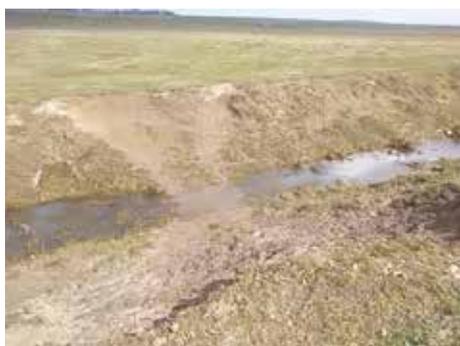
Figure 5. Drain holes to clogged

The clogging of the Somuzel collector channel has led to the clogging of the discharge outlet of the collector drains and their decommissioning (Figure 5). The repetitive and uncontrolled passage of animals over the channel network through unscheduled places led to clogging on the sections and the creation of back slopes that favoured water stagnation and sedimentation of alluvium.

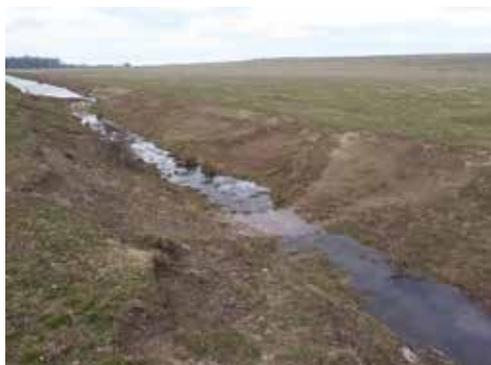
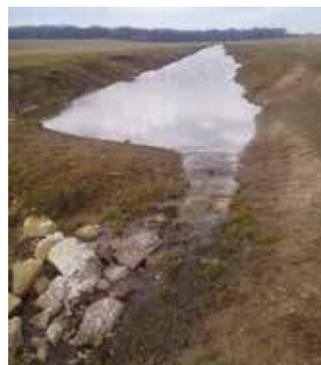
Figure 6. Arranging watering holes on the Somuzel collecting channel

The layout of a dam on the Somuzel collector channel for the accumulation of water for watering the animals accelerates the erosion and clogging of the channel and favours the prolongation of the excess moisture in the adjacent area (Figure 6).

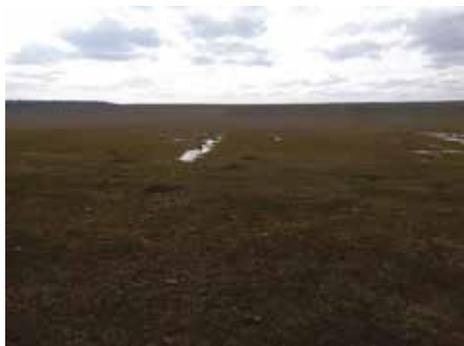
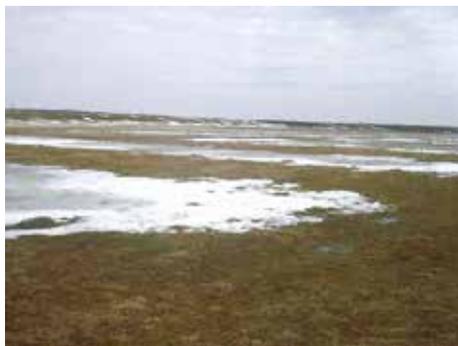
Figure 7. Water stagnation in microdepressions

The decommissioning of the drainage network through the clogging of the discharge outlets favoured water stagnation in the micro-depressions formed on the drained surface (Figure 7). These microdepressions formed during the exploitation period as arable land have expanded due to the stagnation of the water for a long time, the settling of the surface planted and the soil's kneading by animals

during grazing. The gradual increase in water stagnation is due to greater susceptibility of soils to softening with excess moisture. The flat lands situated at the base of the slopes between the two ring channels are most affected by the spring rains that coincide with the melting of snow. The water cannot leak to the surface of the soil and the drainage does not

occur due to the discharge outlets of the destroyed and clogged collector drains.

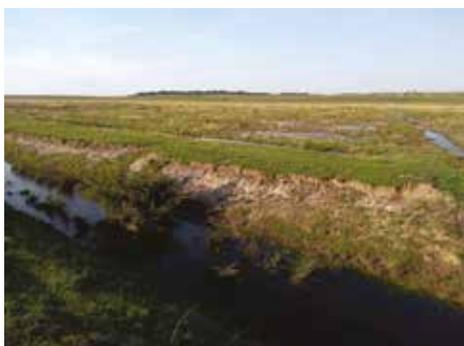
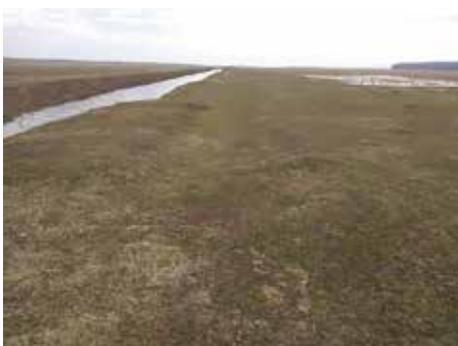
Figure 8. Landfill sites modelling along channels

Water stagnation is also favored by the landfill sites resulted from the excavation of the

channels that have been leveled along the canals over a width of about 20 m, the resulting platforms having a height of up to 0.50 m (Figure 8).

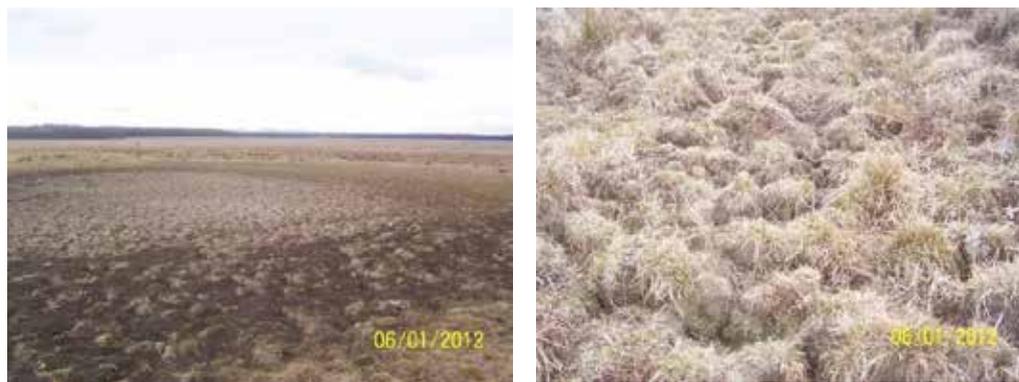
Figure 9. Destroyed vegetational cover

85-95%. If grazing starts too early, when plants that are too young and the soil that is too wet destroy the celery layer, the soil is struck and soil air is getting worse. Pits and heaps are also formed (Figure 9), and young plants with reduced foliar surface use for their restoration reserve substances accumulated in the organs in the soil, which lead to their exhaustion.

Excessive grazing when soil is moist makes the vegetable cover be destroyed by clogging.

The wetter soil becomes, the lower the ability to withstand compaction and subsidence is, causing the asphyxiation of plants.

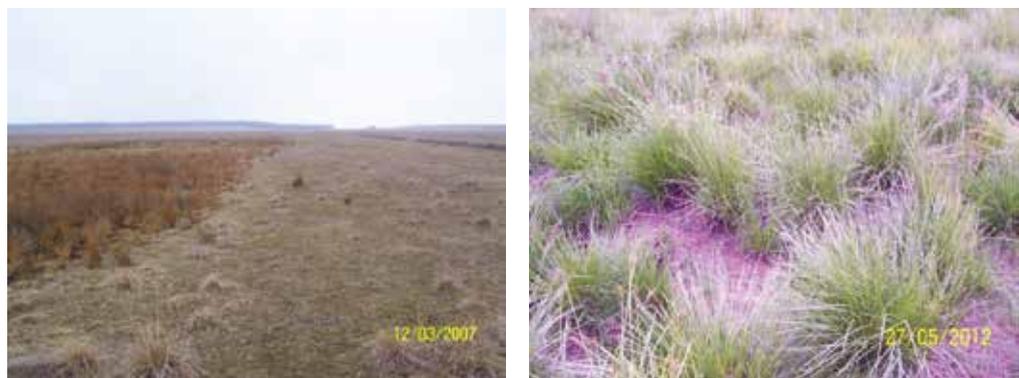
Figure 10. Hydrophilic vegetation

Thus, valuable, more demanding species of water, air, and soil have disappeared from large areas and have been replaced by hydrophilic

species with very low fodder value: *Carex caryophylla*, *Carex praecox*, *Juncus trifidus*, *Juncus effusus*, *Agrostis stolonifera*, *Ranunculus repens*, *Ranunculus acris*, *Ranunculus sceleratus*, *Glyceria maxima*, *Glyceria frutans*, *Galega officinalis* and *Trifolium fragiferum* (Figure 10).

The measures necessary for the recovery of the grasslands with the destroyed vegetal cover consist in the rehabilitation of the draining systems, the upturning of the grazing fields and the sowing and the elaboration of a grazing arrangement. The widespread application of such large-scale measures is unlikely due to the lack of support and financial resources. In this situation, the authors recommend concentrating the efforts of local authorities to facilitate the leakage of water to the surface by making trenches, the unclogging of discharge outlets of collecting drains, banning grazing in moist soil areas and the interruption of grazing by at least 3-4 weeks before the first frost.
