STRUCTURAL VIBRATION AND FIRE RESISTANCE

Abstract

1. *Structural characteristics of the studied building: The Faculty of Horticulture from 59 Marasti Blvd, Bucharest (Dragomir et al., 2013)*

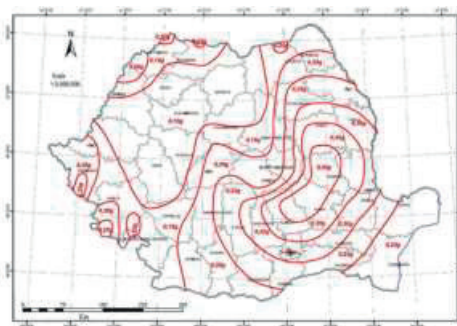
Figure 1. Peak ground acceleration map of the Romanian territory (P100-1/2013)

In Romania, the seismicity of Vrancea source is very important (Figure 1), with a maximum instrumentally measured magnitude of 7.7, maximum possible magnitude of $M_w = 8.0$ (it was obtained for 1940, 1977, 1986, 1990 earthquakes), the frequency content showing significant differences in source mechanisms, with a directivity between events and, for soil conditions in Bucharest, a long predominant period of ground vibration of $T = 1.4-1.6$ s etc. (Lungu et al., 2004) (Radulian and Popa, 1996). In these conditions, reducing the seismic risk of buildings is a complex action, of national interest.

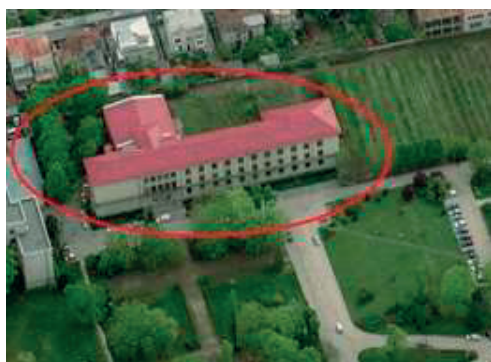
It was built during 1950s with basement + ground floor + 3 storey height regime and two bodies (B1 and B2) separated by an expansion joint (no role as a seismic point) (Figure 2).

Figure 2. The building with the two sections, B1 and B2

The two differ structurally: B1 has a structure consisting partly of structural walls of brick masonry and partly of reinforced concrete

columns, on which the monolithic reinforced concrete floors are supported; B2 has a structure consisting of structural walls made of brick masonry on which the monolithic reinforced concrete floors are supported.

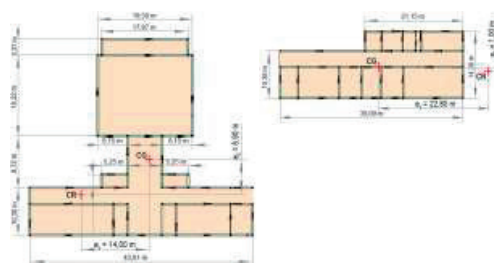
- evaluation of structural regularity both in plane and vertically (Dragomir et al., 2013), by calculations in order to determine the relative position between the two intrinsic centres (eccentricities e_x and e_y), the centre of gravity - CG and the centre of rotation - CR. Body B1, $e_x = 14.0$ m, $e_y = 6.9$ m; Body B2, $e_x = 22.8$ m, $e_y = 1.0$ m (Figures 3 and 4).

Figure 4. Eccentricities on the two orthogonal directions

The plan shape of the buildings is irregular, asymmetrical, presenting discontinuities, which lead to the appearance of additional code demands. The values, shown in the above figures, indicate that the plan of the building does not comply with the regularity conditions.

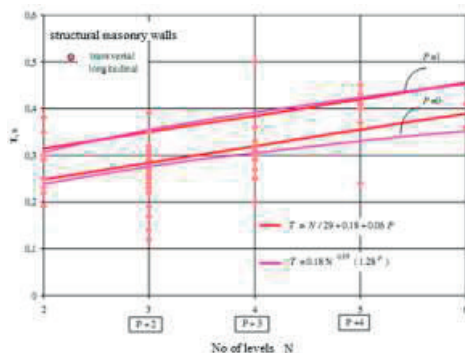
- validation of the results obtained through temporary seismic instrumentation, by comparing with the fundamental periods of other existing buildings with reinforced concrete structural system or structural masonry walls (representation based on studies conducted within the INCD URBAN-INCERC, in different time periods) (Figures 9 and 10).

Figure 10. Fundamental periods values for buildings with structural masonry walls

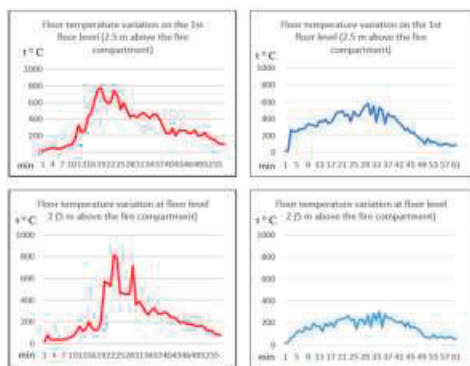
Figure 12b. Temperature-time behaviour on 2 vertical levels of test model (Simion et al., 2019)

The choice of such a solution could be justified by the results of the tests carried out at the INCD URBAN-INCERC, which highlighted that the perimeter bonding to the support wall of polystyrene sheets with adhesive mortar together with the solution of planking the windows and doors with non-combustible barriers, having a width equal to of polystyrene, provides a high degree of fire safety for the used system in order to obtain the external thermal insulation of a building.
