## WATER EROSION OF SOILS IN THE HILLY AREA OF DOLJ COUNTY - ASSESSMENT, CONTROL AND MITIGATION METHODS

Cristian POPESCU, Mihaela BĂLAN, Marius-Nicolae CIOBOATĂ

University of Craiova, Faculty of Agronomy,  
19 Libertatii Street, Craiova, Romania

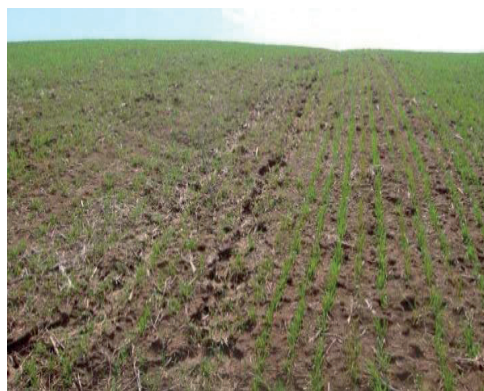
Figure 1. Natural erosion in the hilly area of Dolj County

On lands with an even slope, surface erosion manifests itself normally on extended surfaces (Figure 1), because it occurs without the anthropic influence intervening and consists in

the gradual and slow detachment and transport of material from the solidified surface (Popescu, 2017; Ciocan et al., 2020).

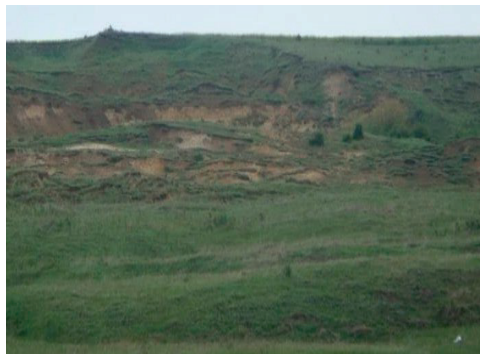
Figure 3. Landslide in the hilly area of Dolj County

Having in view these aspects, we can say that we cannot talk about sustainable and efficient development in agriculture, without invoking soil fertility as a decisive factor (Borlan & Hera, 1984). Two major degradation phenomena that occur in the hilly area of Dolj County are soil water erosion and landslides, both diminishing soil fertility (Figure 3).

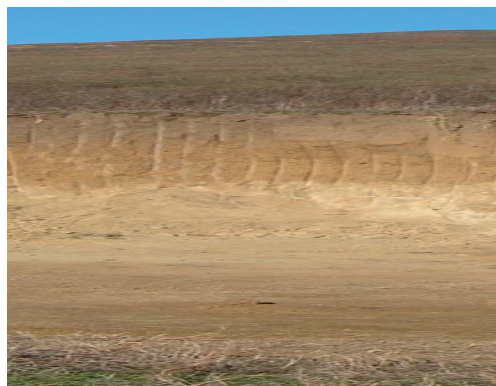
Figure 4. Soil profile on rupture terrain with natural erosion

Laboratory analyses related to the erosion process on soil samples taken from the field soil profiles. Soil profiles of areas subject to natural and accelerated erosion were studied during the field phase. During the field phase, soil profiles were examined, and soil samples were taken in areas of natural morphological variation (Figures 4 and 5).

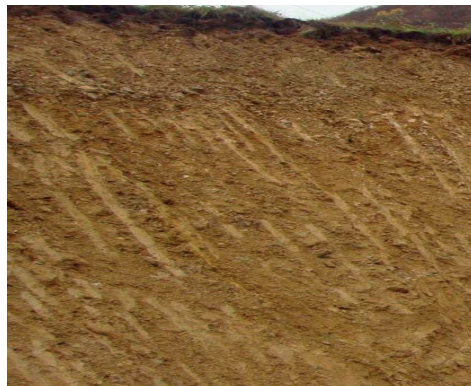
Figure 5. Soil profile on rupture terrain with accelerated erosion

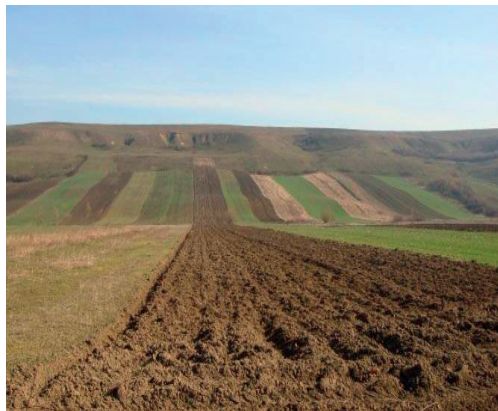
Figure 6. The aspect of the terrain in the form of belts (strips) on the line of highest slope in the hilly area of Dolj County

after the application of Law 18/1991, when the land was restituted to the owners on the old sites. They have the appearance of belts or strips (Figure 6), with small widths of 10-12 m, which cross the plateau, the slope with southern exposure, the valley, the slope with northern exposure and end in the plateau from the opposite direction, sometimes stretching on a length of 1-2 km. In this way, all the agricultural tillage on the sloping lands were carried out from the hill to the valley, on the line of the greatest slope, and the erosion process manifested itself more intensively.

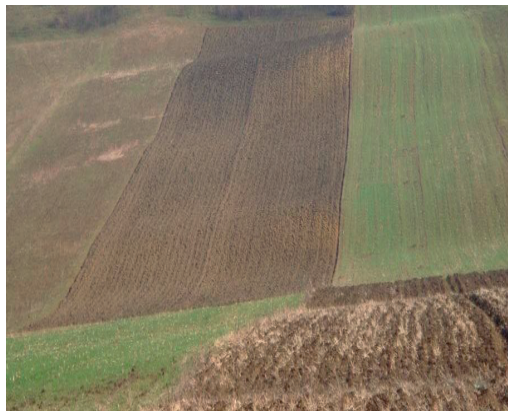
Figure 7. Lower genetic horizons emerged on even-slope slopes in the hilly area of Dolj County

On these soils erosion is imperceptible, but there are situations when it can be easily observed where lower genetic horizons appear on the soil surface (Figure 7).

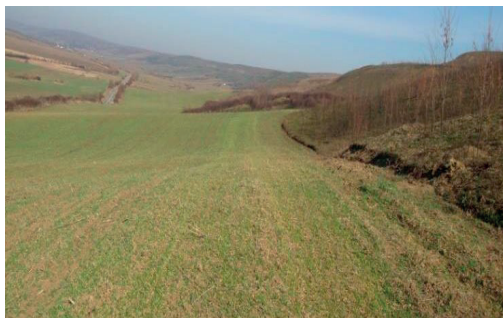
Figure 8. The seeding operation carried out along contour lines on a uniform slope in the hilly area of Dolj County

The execution of all technical works on contour (Figures 8 and 9), the use of crops that are sown in dense rows (Figure 10), the realization of a suitable crop rotation, the administration of organic and chemical fertilizers, are works aimed to preventing erosion by improving the capacity of water infiltration and the reduction of the dispersion of soil particles during precipitation and of course the increase of fertility and the obtaining of higher agricultural productions (Irimuş et al., 2017).

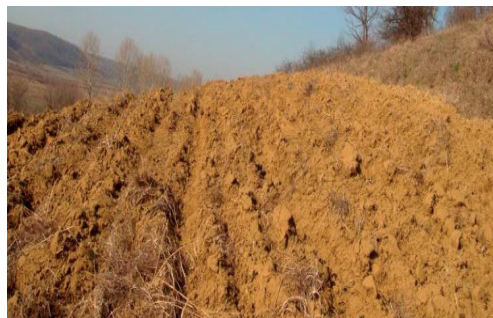
Figure 9. Plowing performed along contour lines on a uniform slope in the hilly area of Dolj County

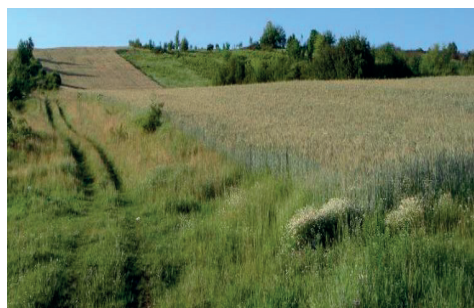
Figure 10. Wheat crop on land with a uniform slope in the hilly area of Dolj County

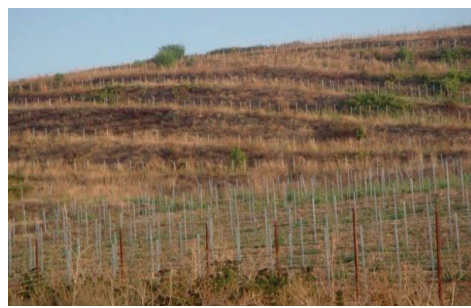
Figure 11. Terraces with vines on sloping land in the hilly area of Dolj County

On the lands affected by the accelerated erosion, the efficient works involve the

construction of terraces for the vineyards (Figure 11) and afforestation (Figure 12).

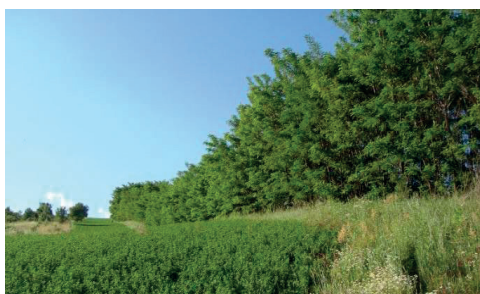
Figure 12. Afforestation with acacia, on land with a large slope and in the form of a strip in the hilly area of Dolj County
