## ESTIMATION OF RIVERBANK SOIL EROSION RATE - A CASE STUDY

*Erosion of riverbanks is a natural phenomenon, which leads to the loss of important agricultural land areas. At the same time, riverbank erosion can be considered a natural risk that can cause major damage to road and railway infrastructure, flood management infrastructure, biodiversity and even the population located in flood risk areas. This phenomenon is generally more pronounced in the meanders of the rivers and in regions with higher flow rates, but it can be accentuated due to climate change which can lead to changes in watercourse flows. This study aimed to estimate the net annual soil loss due to riverbank erosion on the Siret River, Romania, using aerial photogrammetry and GIS analysis.*

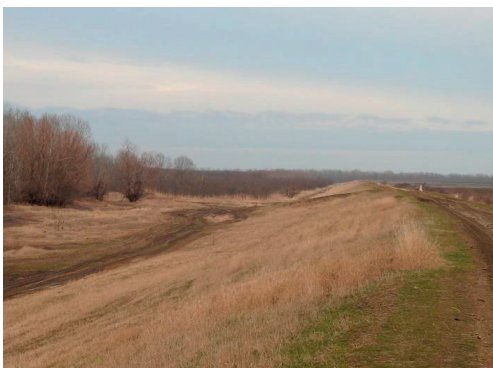
Figure 3. The flood protection dike Nămolosa-Măxineni

Taking the construction decision of riverbank erosion prevention works must balance the need to secure the Nămolosa-Măxineni flood protection dike (Figure 3) to prevent the risk of floods.

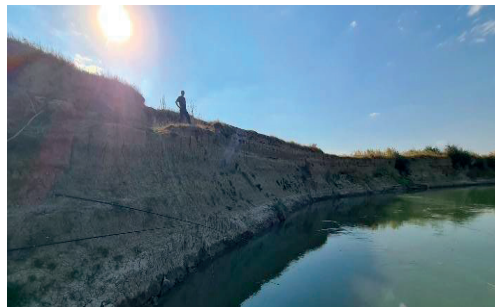
Figure 4. Riverbank erosion in the study area (original)

In Figures 4 and 5 present the riverbank erosion from Siret River.

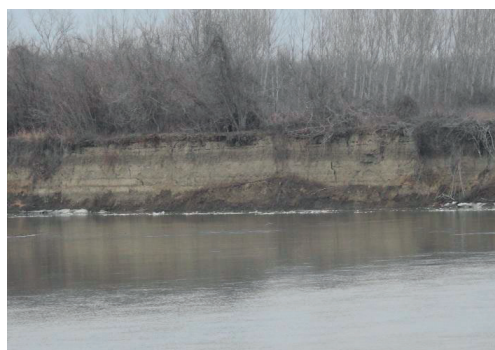
Figure 5. Riverbank erosion in the study area

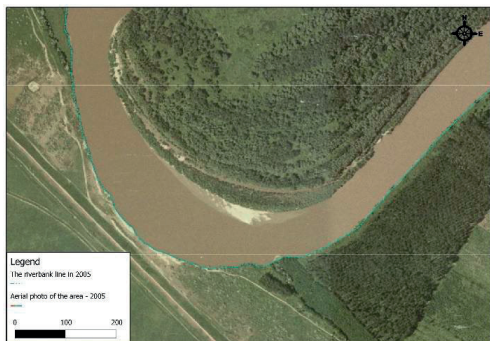
Figure 6. The riverbank line in 2005

As a result of this study, the riverbank surface lost due to erosion in the study area was calculated, and it was found that during the period 2005-2016, approximately 3,313 hectares were lost (approx. 0.3 hectares/year) (Figures 6, 7 and 9). In this interval, riverbank erosion was between 10.5 and 81 meters, resulting in an erosion rate between 0.26 cm/day and 2.02 cm/day. The land areas lost through erosion were calculated by measuring the areas lost in the interval between the study years using the QGIS software, and the results obtained were divided by 11 years between the study intervals. To calculate the daily riverbank erosion rate, the distances by which the erosion advanced between the years of the study were measured, and the results obtained in centimetres were divided by the number of days between the years of study (approx. 4015 days).

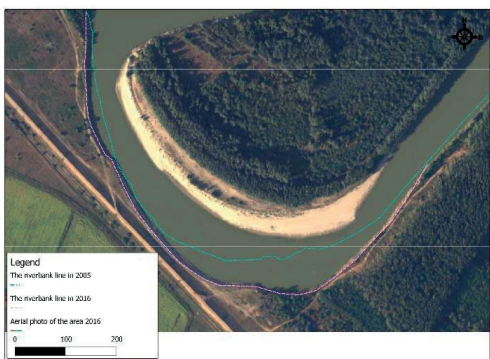
Figure 7. The riverbank line in 2016

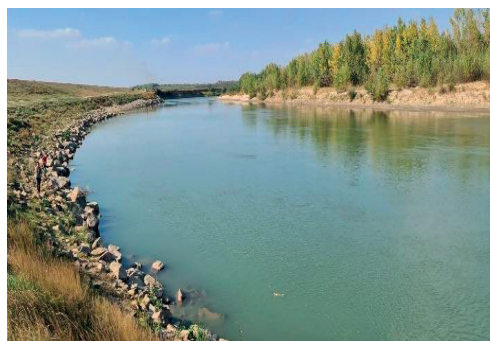
Figure 8. Anti-erosion works carried out in the area

Also in this interval, the water management authorities carried out a lower-bank riprap erosion prevention construction, which stopped riverbank erosion on a section on a section of 380 m (Figure 8). Following the evolution of erosion in the period 2016-2023, it was found that the erosion phenomena continued upstream and downstream of the riverbank anti-erosion construction, while in this area the phenomenon of riverbank erosion stopped (Figures 9 and 10).
