RIVER CORRIDOR CHANGE DETECTION USING SATELLITE IMAGERY AND LIDAR DATA: A CASE STUDY OF THE SIRET RIVER NEAR CORBU VECHI VILLAGE

Key words: remote sensing, change detection, river, GIS.

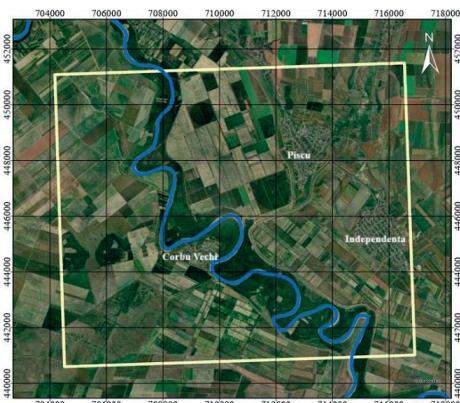
Figure 1. Siret River near Corbu Vechi village

The primary aim of this study is to identify changes in the river corridor. The area of interest is located near Corbu Vechi village, in Brăila County, as shown in Figure 1, where the Siret River has been monitored from 2016 to 2025 using satellite images from Sentinel 2 RS (Remote Sensing) data. These changes are validated through topographical data collected in February 2025 with a LiDAR (Light Detection and Ranging) sensor mounted on an UAS (Unmanned Aerial System). This approach provides valuable insights into the evolution of river ecosystems over the specified period, offering a detailed assessment of the river's dynamics.

The area of interest lies in the lower Siret Valley, with elevations between 3 and 60 meters. During the 70's, extensive engineering projects were undertaken to manage frequent flooding and bank erosion, particularly in the floodplain. These efforts included regularizing the river's course and reinforcing its banks (Olariu et al., 2015).

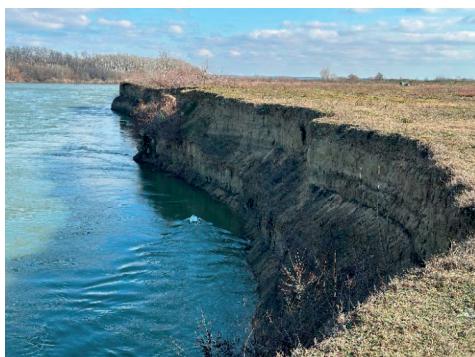
Figure 3. Bank erosion Siret River near Corbu Vechi village - February 2025

The Siret sector from Movileni to its confluence with the Danube, where the area of interest is situated, faces exceedances of flood protection works, as it is entirely embanked. Rising water levels are sometimes aggravated by a backflow effect from the Danube, which can contribute to an additional rise in water levels in certain sections of the Siret River. In this context, confluence areas, such as those where the Siret meets major tributaries, are exposed to flooding from both the Siret and its tributaries. At the same time, in this sector, the Siret is also affected by phenomena such as bank erosion, as can be observed in Figure 3.

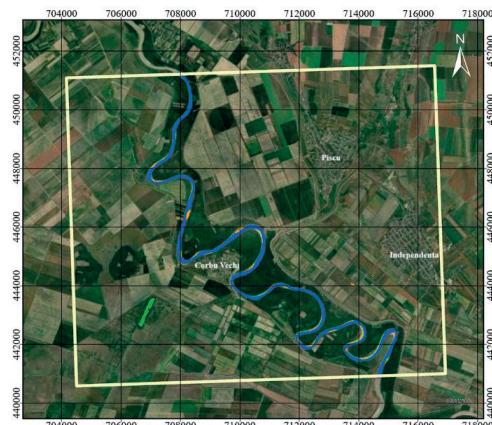
Figure 6. Spatio-temporal changes in water bodies between 2016-2025 based on NDWI Index

A closer look reveals the dynamics of the changes that have occurred along the river course, an aspect highlighted in Figure 6. These changes occurring in the water bodies are caused by bank erosion and sediment deposition, which have led to shifts in the river's path.

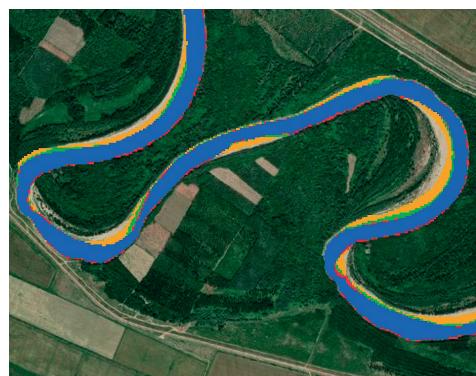
Figure 7. Water bodies dynamics between 2016-2025 based on NDWI Index (orange - 2016, green - 2019, red - 2022 and blue - 2025)

In Figure 7, the evolution of the Siret River between 2016 and 2025 is illustrated using different colors to represent the river's path each year. The river exhibits significant lateral migration over this period, with visible zones of bank erosion and sediment deposition occurring along various segments of its meandering course. These geomorphological processes are

primarily governed by the highly sinuous morphology of the Siret River in this sector, where the channel forms pronounced meanders. The observed pattern of bank erosion on the outer curves and sediment deposition on the inner curves is consistent with classical fluvial dynamics described in meandering river systems. In such systems, higher flow velocities on the outer bends lead to increased erosive forces, while lower velocities on the inner bends favor sediment accumulation. This natural mechanism of lateral channel migration contributes to the continuous reshaping of the river corridor over time.

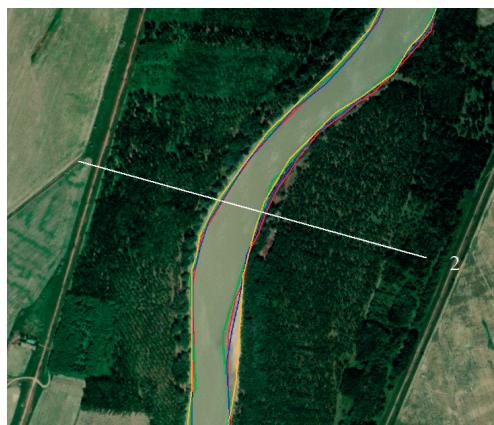
Figure 9. Cross-section 2

The linear flow of the river, characterized by its relatively straight course in this section, contributes to some degree of erosion and sediment deposition. However, its effects are less pronounced compared to areas with more pronounced meanders. The forest belts, on the other hand, provide some stabilization to the riverbanks by acting as a natural barrier against water-induced erosion. While these forest belts can reduce bank erosion to a certain extent, their impact remains limited.

Based on Table 1 it can be concluded that the studied area exhibits changes in certain profiles. For example, cross-section 2 maintains a relatively consistent width throughout the studied period, with only minor variations. This data can be correlated with Figure 9, where the changes observed in the river's course are influenced by the linear flow of the Siret River and the presence of forest belts along the banks.

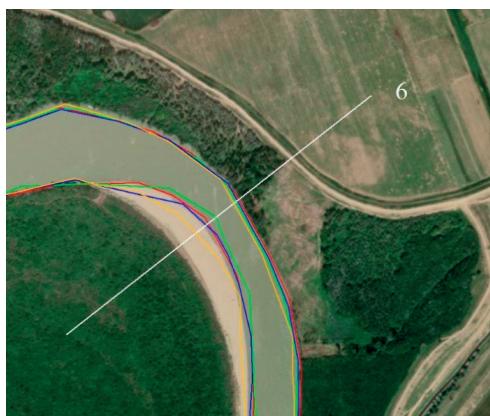
Figure 10. Cross-section 6

In contrast, cross-section 6 shows major changes, and when correlating the data with Figure 10, it can be concluded that cross section 6 is located on a river meander, where the phenomena of transportation and deposition of alluvial materials occur.

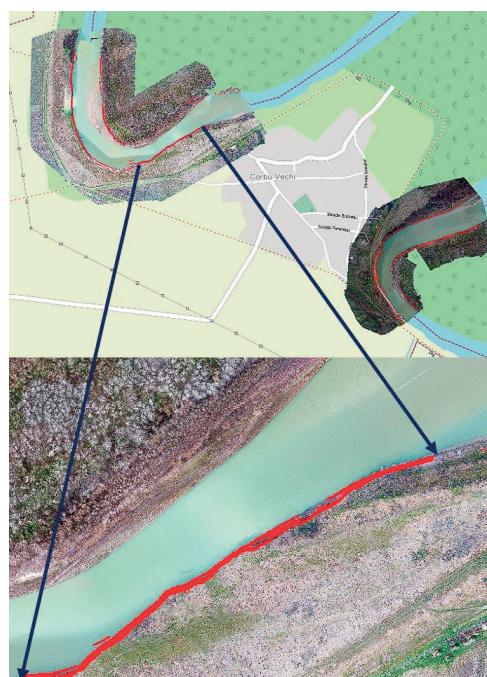
Figure 13. Slopes with an inclination between 30 and 70 degrees - with color red

The Digital Terrain Model was imported into ArcGIS Pro for detailed analysis of the slope characteristics within the study area. Through this analysis, regions with higher risk were identified and marked in red as can be observed in Figure 13.

These areas, where the slope of the riverbank ranges from 30 to 70 degrees, extend over

approximately 2,115 meters on the DTM near the cross-section 5 area and around 1,350 meters in the vicinity of cross-section 7, as determined through slope length calculations performed in ArcGIS Pro. These zones were flagged as particularly vulnerable, specifically, for slopes between 30 and 50 degrees, it is typically recommended to implement bank stabilization measures. These include the installation of protective mesh, as well as the planting of trees, shrubs, and other vegetation to help secure the soil and prevent further erosion. For areas where the slope exceeds 50 degrees, the erosion risk is significantly higher, and more solid engineering solutions are required. In these situations, it is necessary to construct retaining walls, gabion baskets, stone revetments, or even apply concrete to the embankment to stabilize the slope effectively. These engineering measures provide structural support to prevent soil movement and mitigate the long-term risk of erosion, ensuring the durability of the riverbank in the face of continuous environmental pressures.

The slope analysis aligns with the study's main objective outlined in the title and abstract, detecting changes within the Siret River corridor using satellite imagery and LiDAR data. By identifying steep riverbanks ranging from 30 to 70 degrees near cross-sections 5 and 7 based on the DTM, the study highlights areas with elevated erosion risk. These results also support the secondary objective stated in the abstract: providing an overview of the current condition of the river corridor and assessing riverbank stability. Steep slopes significantly influence erosion processes and increase the likelihood of landslides. The use of the Digital Terrain Model enables a detailed spatial assessment of these vulnerabilities, while satellite imagery facilitates the evaluation of changes over time in a spatio-temporal context. These analyses enhance the study's value in detecting changes and evaluating current geomorphological conditions, while also identifying high-risk areas to guide effective mitigation strategies.
