THE APPLICABILITY OF GIS TECHNOLOGY IN THE STUDY OF RIVERBED DYNAMICS AND MORPHOLOGY

Gabriela BIALI¹, Maria Catalina PASTIA¹,
Paula COJOCARU¹, Carmen Elena MAFTEI²

Abstract

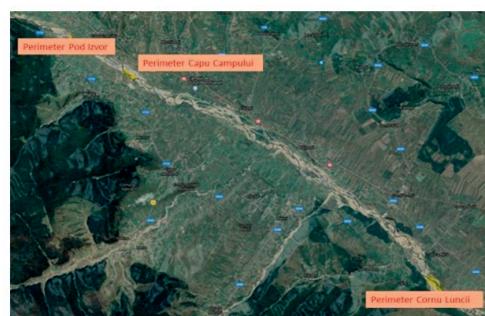
According to detailed geomorphological mapping by Rădoane (2007), the middle sector of the Moldova River in Suceava County, between Păltinoasa and Cornu Luncii, features a well-developed alluvial plain with alluvial terraces rising 4-5 meters above the current riverbed. Key extraction perimeters within this area include Pod Izvor, Capu Câmpului, and Cornu Luncii (Figure 3).

Figure 3. Plan with the location of the three exploitation perimeters. Source: Google maps

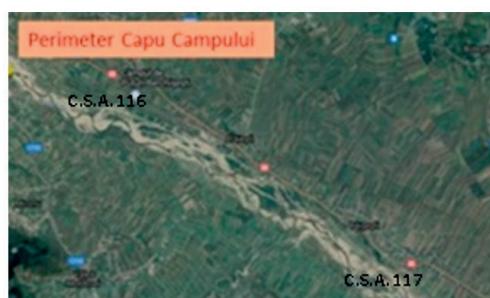
The Capu Câmpului extraction site is located outside the built-up area (extravilan) of Capu Câmpului village, Suceava County, along the riverbed of the Moldova River, just downstream of the confluence with the Isachia stream. The operational perimeter lies between cadastral markers C.S.A. 116 and C.S.A. 117 (Figure 4).

Figure 4. Plan with the location of the Capu Câmpului exploitation perimeters. Source: Google maps

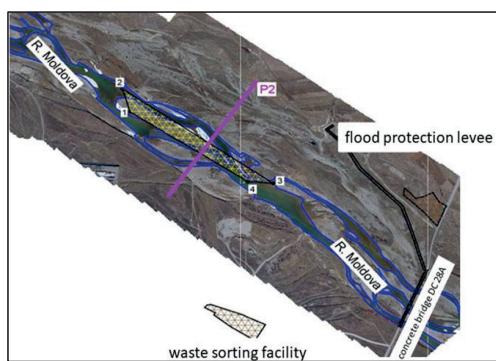
The study commenced in 2017 with field measurements conducted across five cross-sections (P1-P5). Figure 5 shows the 2017 boundary of the mineral aggregate extraction perimeter (points 1–2–3–4) along the Moldova River bed.

Figure 5. Orthophotomap of the Capu Câmpului perimeter from 2017

The total length of the exploitation perimeter is approximately 595 meters, with a maximum extractable volume (V_{\max}) of 18,600 m³. Based on the 2017 volume calculations, the sand and gravel reserve within the analyzed section - spanning approximately 595 meters of the riverbed - was estimated at $V_i = 18,600$ m³ per gravel bar. Figure 7 shows the 2019 boundary of the mineral aggregate extraction perimeter along the Moldova River bed.
