BUILDINGS BEHAVIOUR TO SEVERE SURFACE EARTHQUAKES (CHILE 2010, NEW ZEALAND 2011, TAIWAN 2016)

Claudiu Sorin DRAGOMIR^{1,2}, Daniela DOBRE^{2,3}, Emil-Sever GEORGESCU²

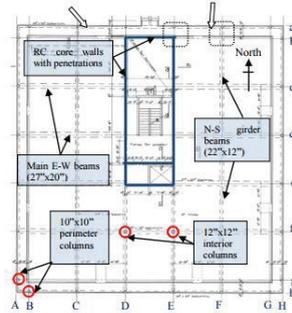
Figure 11. Plan view of the typical upper floors (2nd to 4th Floors).

- because it was a building built before the introduction of modern seismic design codes (1963 and 1964)
- due to the building had several critical reinforcement deficiencies (lack of shear reinforcement of nodes, inadequate anchoring beam-column/wall;
- soffit of slab showing where slab reinforcement has been ripped from slab;

- typical perimeter beam/column joint, with lack of joint ties;
- fractured slab reinforcement at wall/roof slab interface on the east side of the shear core etc.)

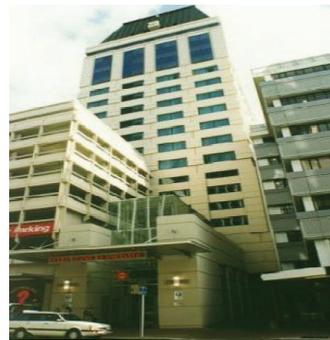
Figure 17. View of the Grand Chancellor before 2011 earthquake (<http://www.building.govt.nz>)

Vertical irregularity arises from the fact that the upper tower relies on frame action (moment-resisting reinforced concrete frames) for its seismic resistance while the lower tower relies on reinforced concrete shear walls. The two structural forms inherently have different stiffnesses and, if not linked, would respond differently to seismic shaking. The horizontal irregularity arises from the fact that the eastern bay of the building is cantilevered. Large cantilever transfer beams

extend out to the east at levels 12 to 14 above Tattersalls Lane to support the car park floors. The wall with a plate cantilever supported between 600 and 800 tons from weight higher levels. It is estimated that during the earthquake, this wall has undergone a request side 1800 to 2400tf. Two of these cantilevered transfer beams sit on top of the key supporting shear wall (wall D5-6), Figure 17. The damaged foundations lead to the visible leaning of the building to one side, Figure 18.

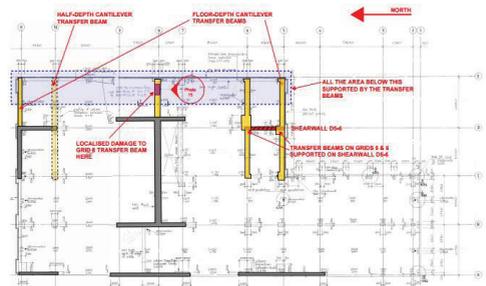
The building suffered structural damage, caused by the collapse of a key supporting shear wall "D5-6" located in the south-east corner of the building, Figures 20...23. The shear wall was responsible for roughly one-eighth of the Hotel Grand Chancellor's mass.

Figure 21. Level floor plan, with the shear wall D5-6 (<http://www.building.govt.nz>)

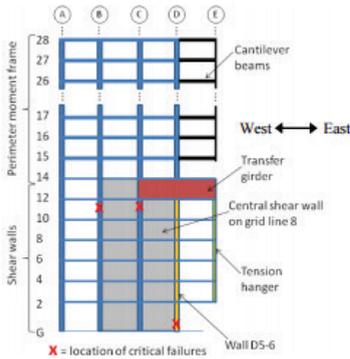
Figure 23. Schematic plan and elevation of the Grand Chancellor Hotel. The floor numbering is based on the original construction drawings – the lower 14 floors are half-height car park floors (<http://www.nzsee.org.nz>)

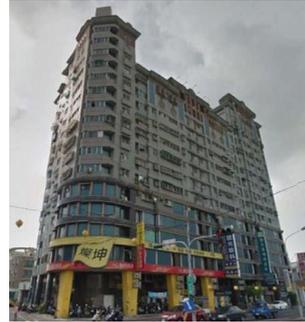
Figure 26. Weiguan Jinlong residential building before earthquake

- the design of the construction did not match calculations made in its structural and steel blueprints;
- the difference in stiffness between the apartments above and the soft storey below causing failure at the junction between the two (at second floor level);
- at the bottom of the building, a possible soft storey which has caused the overturning of the entire structure;
- the possibility of structural problems related to poor-quality reinforced steel and cement;
- only half the designated amount of reinforced steel beams were used in the construction of the complex, which explains its weak structural integrity;

- there is a high likelihood that the basement acted as a soft storey and caused the building to collapse;
- some residents in the building broke and cleared many in fills and columns of a storey so that more rooms could be arranged for rent.

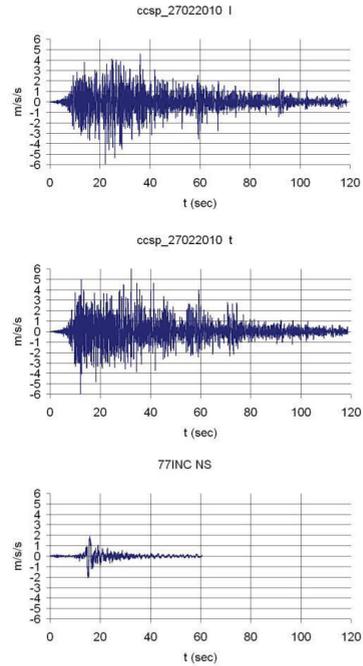
- The recorded accelerograms for Chile *surface earthquake 2010*, at San Pedro Colegio Concepcion (CCSP), 2 horizontal components, and INCERC accelerogram, NS component, registered at Vrancea *intermediate earthquake 1977* (using the same scale) are shown in Fig. 28 [Dragomir et al, 2010].

The recording time of Vrancea seismic motion was approx. half from the recording time of Chile earthquake and the maximum amplitude of the acceleration recorded in Chile is about 3 times higher than the maximum of 1977 recording.

Figure 30. Recorded accelerograms for Chile earthquake 2010, at San Pedro Colegio Concepcion (CCSP)-2 horizontal components, and INCERC accelerogram- NS component, registered in Vrancea earthquake 1977 (Dragomir et al, 2010)

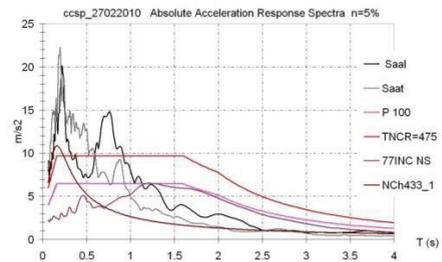
Response spectra in absolute acceleration (5% fraction of critical damping) for the horizontal components of recording from Colegio San Pedro Concepcion and NS component recording from INCERC Bucharest, with the spectrum of Chilean Code NCh433/96 and spectrum from Code P100-1/2006 (corresponding to an earthquake with a mean recurrence interval reference TNCR = 100 years) and for TNCR = 475 years are shown in Figure 29.

Figure 31. Comparative analysis of response spectra in absolute accelerations (Dragomir et al, 2010)

- the maximum value in the range of 0.2 s of Chile Code was exceeded by about 100%, while in the period $T = 0.7\text{s}$ the increase was approximately 250%; in this way, one can explain how some tall buildings of 20 floors, such as the building Torre O'Higgins in Concepcion, were badly damaged.

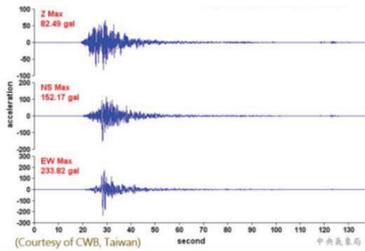
Figure 32. Recorded maximum accelerograms in Tainan City, $a_Z=0.82\text{m/s}^2$; $a_{NS}=1.52\text{m/s}^2$; $a_{EW}=2.34\text{m/s}^2$

About the level of accelerations in Tainan city, they are only with 15% higher than the INCERC 1977 record, but they destroyed buildings with quantitatively consistent reinforcement, but with deficient compliance and detailing.

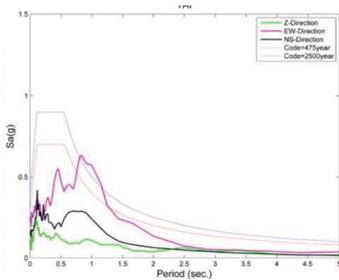
- maximum acceleration 0.22 g EW
- spectrum E-W was approached to the spectrum code with return period of 475 yrs. and it was shifted to the period of 1 s
- the spectrum of the N-S remained in the spectrum code area for return period of 475 years but showed some major peaks between 0.6 s and 0.9 s

Figure 33. Response Spectra Tainan 2016 earthquake (Stone H, 2016, nonsolidground.blogspot.com, accessed February/March 2016)
