## 3D FINITE ELEMENT ANALYSIS MODEL TO ACCESS THE SETTLEMENT OF SOFT SOIL TREATED WITH NANO-MgO

Ahmed AL-RUBAYE, Anton CHIRICA, Ioan BOTI

Technical University of Civil Engineering Bucharest, 124 Lacul Tei Blvd,  
District 2, Bucharest, Romania

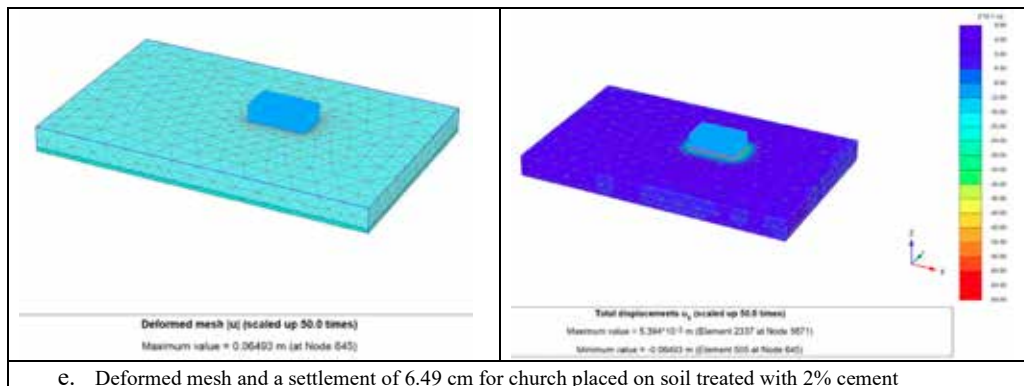
Figure 6. The settlement of the foundation soil

simulations were performed when foundation soil differs. The settlement (Table 3, Figure 6) was calculated when the foundation soil was improved (when the compressibility parameters differ - Table 1).
